Landowners Handbook

**A road map for reconstruction,
management, and long-term maintenance**

Virgin River

Washington County, Utah

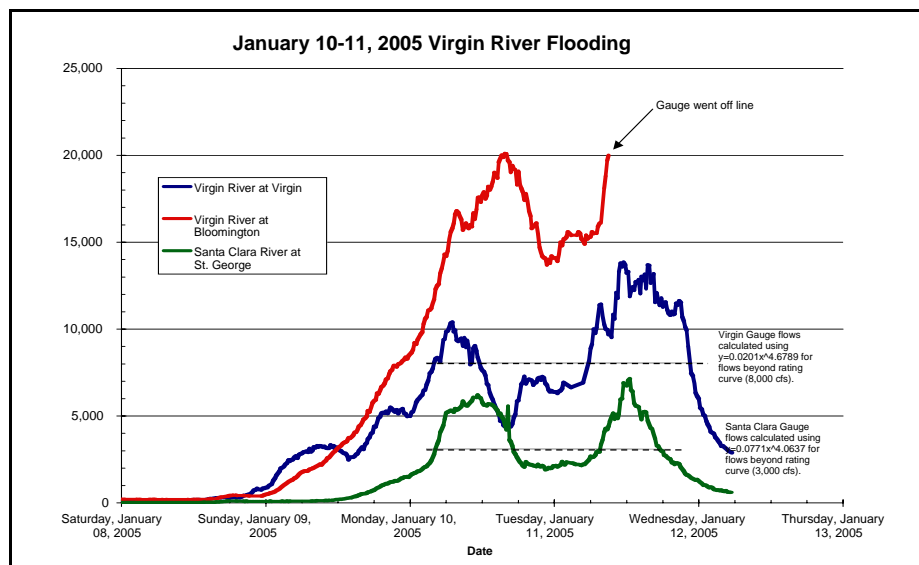
Figure 1 Reconstruction of January 2005 flood flows. (Cram, WCWCD)

The level of impact that a flood has on the surrounding landscape depends on many interacting factors, including the magnitude and duration of high water levels, and the shape and texture of the river channel and its surroundings. Magnitude refers to the size of a flood is just one variable that contributes to the potential for erosion and flood damage. The duration, or length of time, of the high flow event can also significantly affect flood damage. The January 2005 flood had two peaks roughly a day apart. Figure 1 is a reconstruction of the flood prepared by Washington County Water Conservancy District staff. Because the stream gages failed during the floods (dotted lines), peak flows were estimated based on the rising and falling limbs of the hydrograph. Based on these estimates, the Santa Clara and Virgin Rivers experienced high flows for a total of almost 24 hours. The fact that peak flows on the Virgin roughly coincided with the Santa Clara may have further contributed to the impacts.

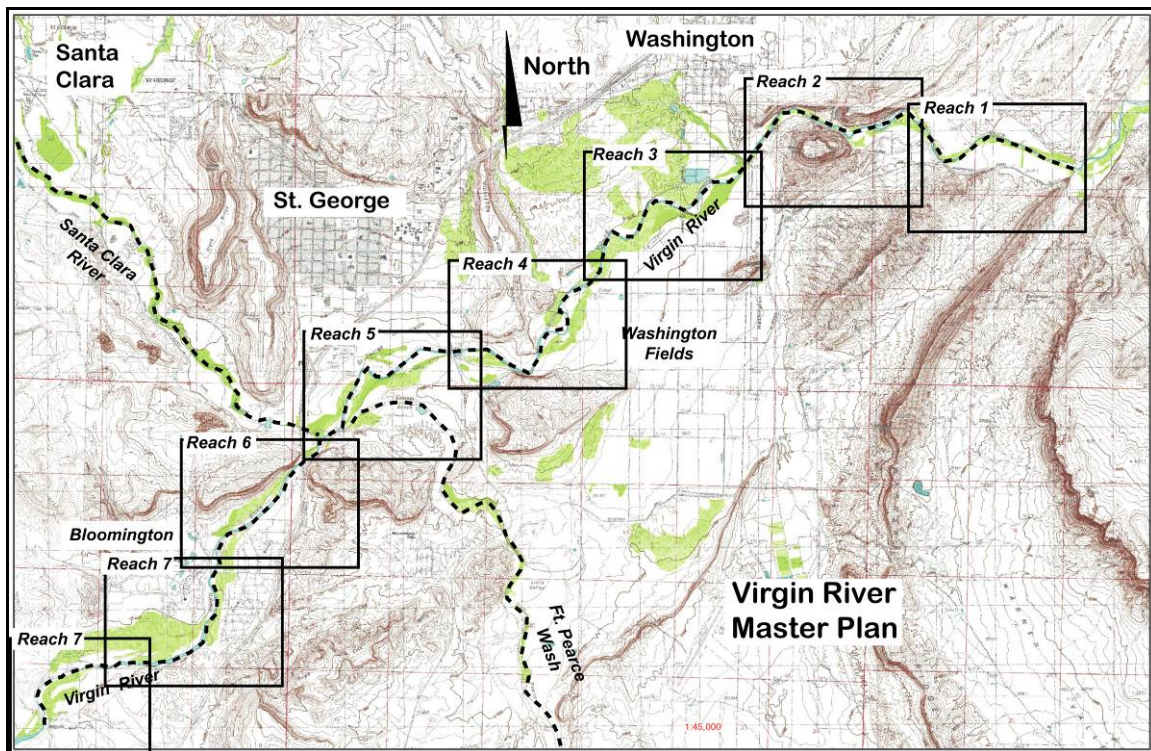
Figure 2 Map of Project Area: Virgin River.

This map presents the Virgin River in southwestern Utah. The river originates in the high elevations above Zion National Park and flows to the southwest before joining the Santa Clara River and Ft. Pearce Wash in the city of St. George, Utah. The project area is divided into 7 reaches.

This Master Plan covers approximately 16.7 miles of the Virgin River from the Washington Fields Diversion to the St. George city boundary (Figure 2). The river is a low-gradient meandering stream with an average slope of approximately 0.0023 foot/foot. The channel bed is gravel and sand. The project lies at an elevation of 2,500 feet and has a watershed area of approximately 4,000 square miles below the confluence of the Santa Clara River and Fort Pearce Wash.

The project area was divided into seven reaches to aid in assessment (Figure 2). Reach 1 is the most upstream reach beginning at the Washington City boundary at Washington Diversion and Reach 7 ends at the downstream extent of the Sun River development in St. George.

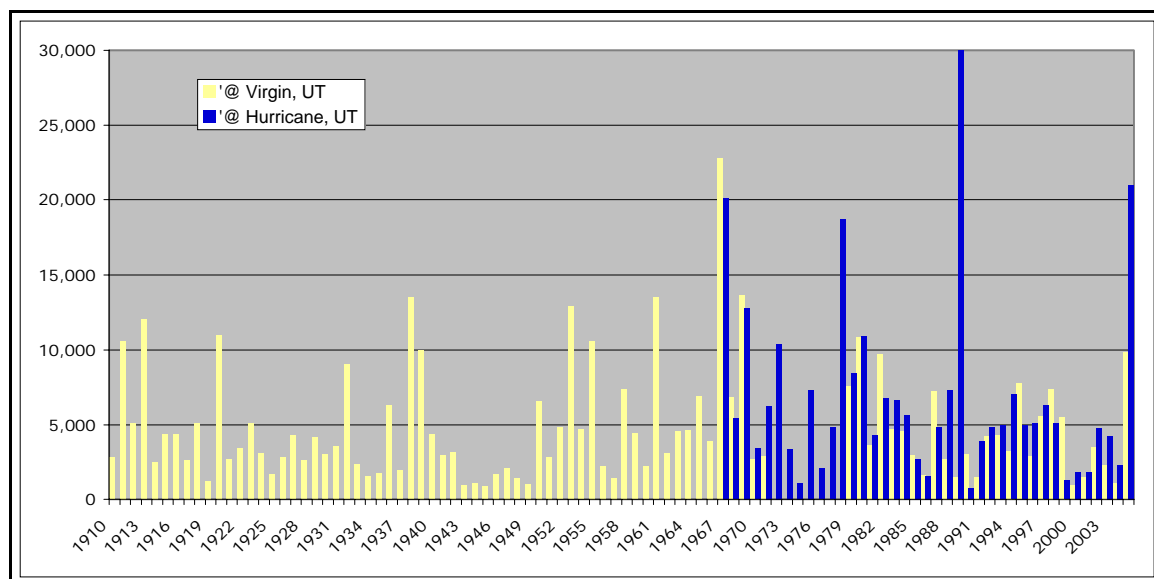
Figure 3 Virgin River Peak Flows at Virgin and Hurricane, UT stream gage stations

Flooding is not uncommon on the Virgin River. Figure 3 presents annual instantaneous peak flows for various flood frequencies at four stream gages. Although the graph shows wetter and drier periods, peak flows are relatively consistent, ranging between 5,000 and 15,000 cfs. Three substantially larger natural floods occurred in the last half of the last century (1967, 1978, and 2005). The 1989 flood event was generated by failure of an upstream reservoir rather than natural storm events. The larger Virgin River flood events are presented in Table 4 and suggests that between 1922 and the 1960's larger flood events were primarily generated by summer and fall storms. Since 1967, these events have been generated by large winter frontal storms.

The 1989 flood event of ~ 60,000 cfs was generated by reservoir failure rather than natural storm generated flood flow.

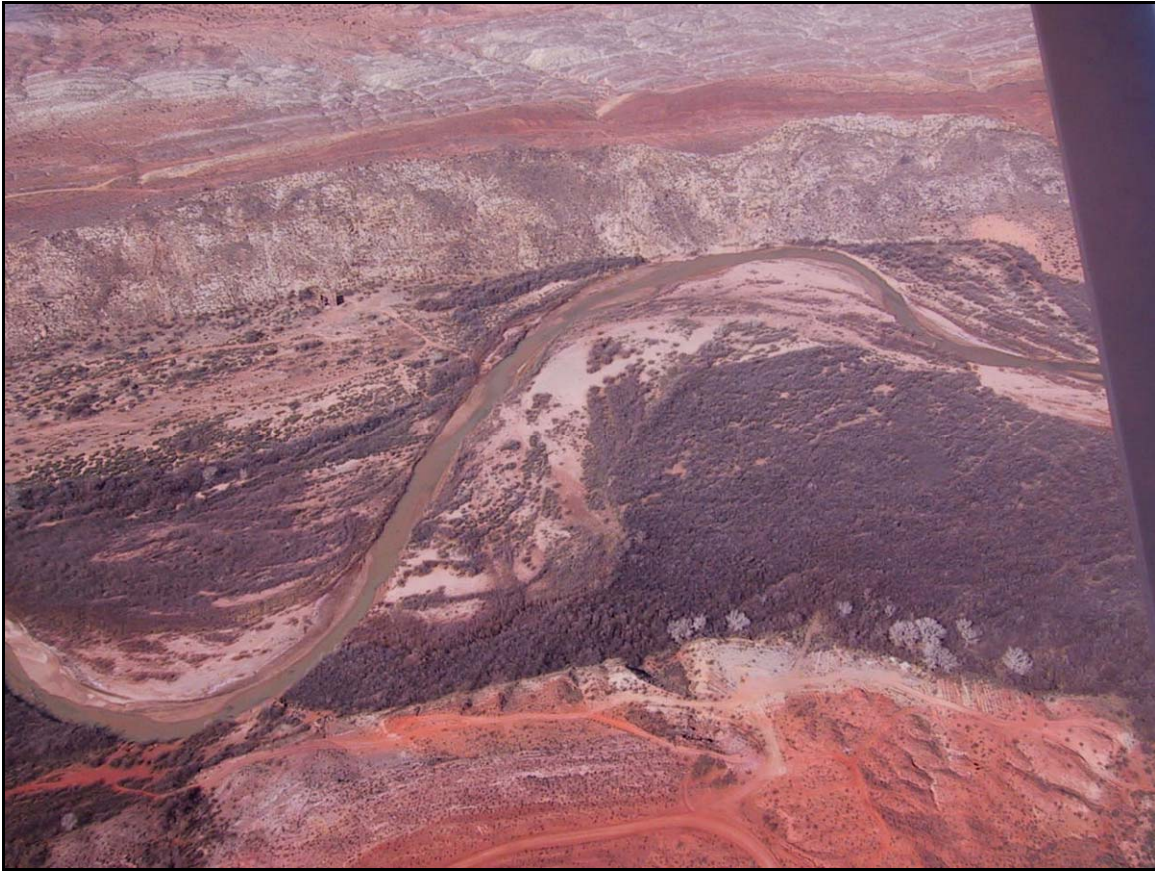
Figure 4 Typical Virgin River meander upstream of project area.

All channels have a characteristic meander or pattern (Figure 4). Low gradient streams are more sinuous than steep ones. The lateral extent, frequency, and radius of curvature are a function of flows, sediment supply, slope, and bank material. Meander allows a low gradient stream to dissipate energy. In gravel streams, bedforms (riffles, pools, and runs) are closely correlated to channel pattern.

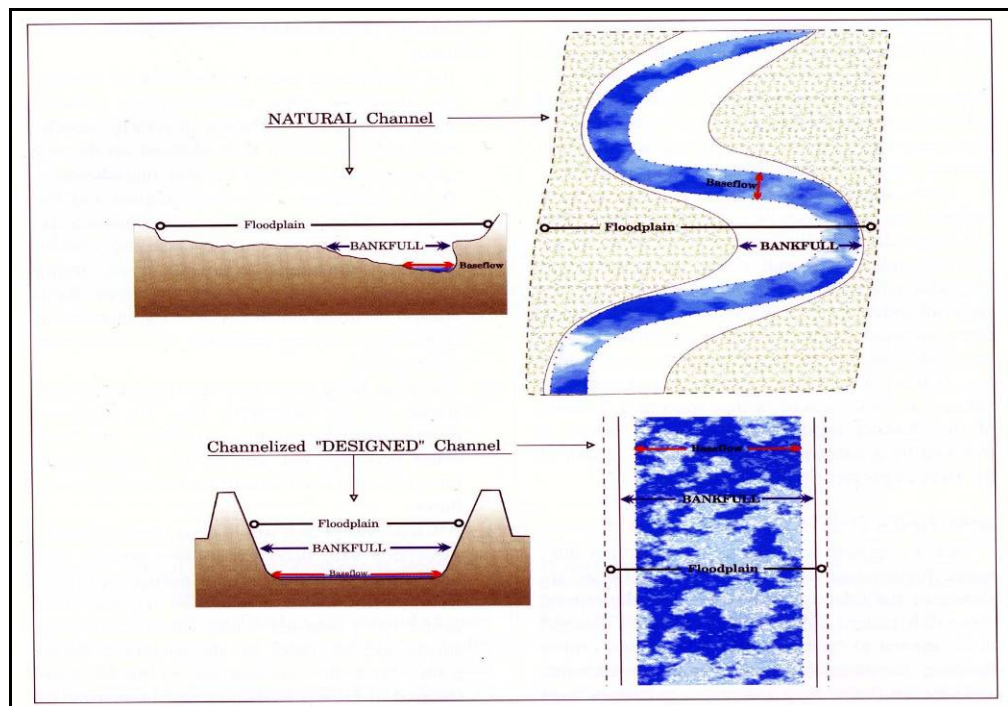
Figure 5. Natural vs. “Designed” Channels.

The stability of any natural channel is dependent on an appropriate dimension, pattern, and profile of the bankfull channel and associated floodplain (Leopold, Wolman, & Miller, 1964). Traditional “designed” or engineered channels remove the natural patterns (Figure 5) reducing the stream’s ability to perform its basic functions. The Master Plan has attempted to identify the stable geomorphic dimensions of the Virgin River and incorporate those into designs to meet specific project objectives. Closely matching the central tendencies of the natural channel results in a design that works with the existing stream processes rather than against it reducing erosion and maintenance cost.

Channel widening is generally intended to increase the capacity of a stream to carry flood flows (Figure 5). Initially this is the case. However, overwidening of the bankfull or central channel decreases sediment transport. In channels with meander, point bars will build, restoring the pre-modification channel width and geomorphic floodplain elevation, thereby negating the modification (Figure 6). In widened channels, sediment deposition over time can raise the channel bed, decreasing capacity and increasing the risk of flooding. Channel aggradation also increases the tendency to meander, increasing the risk of bank erosion.

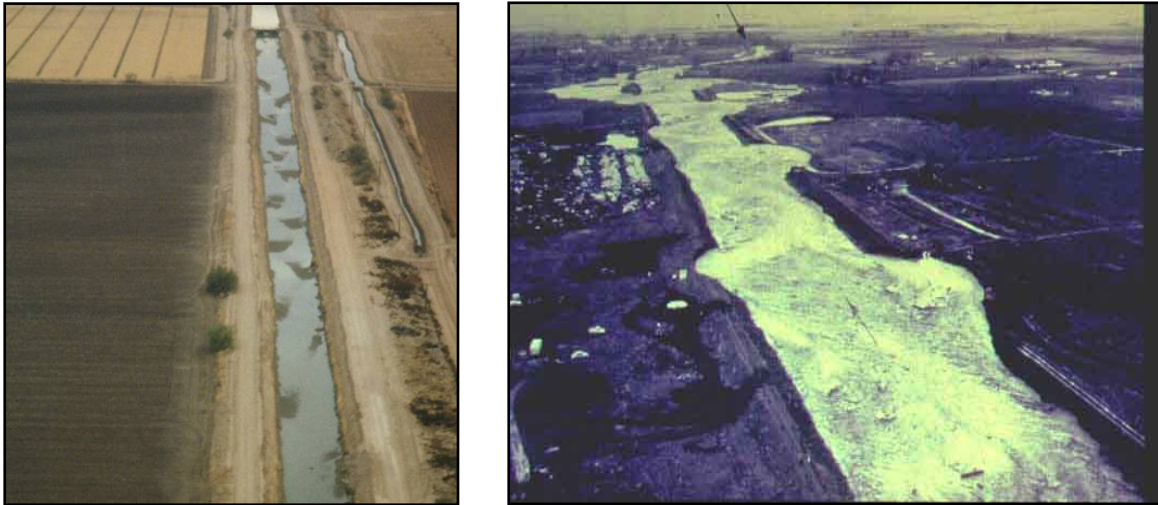
Figure 6 Channel meander and adjustments

Often stream channels are straightened in an effort to increase sediment transport, utilize additional lands and/or decrease lateral movement. However, the loss of meander increases stream power, raising the potential for the stream to erode banks in an effort to dissipate energy. In addition, the stream’s natural tendency to restore its characteristic meander pattern can contribute to stream bank erosion. Without armoring, the stream channel will simply return to its pre-modified condition (Figure 6).

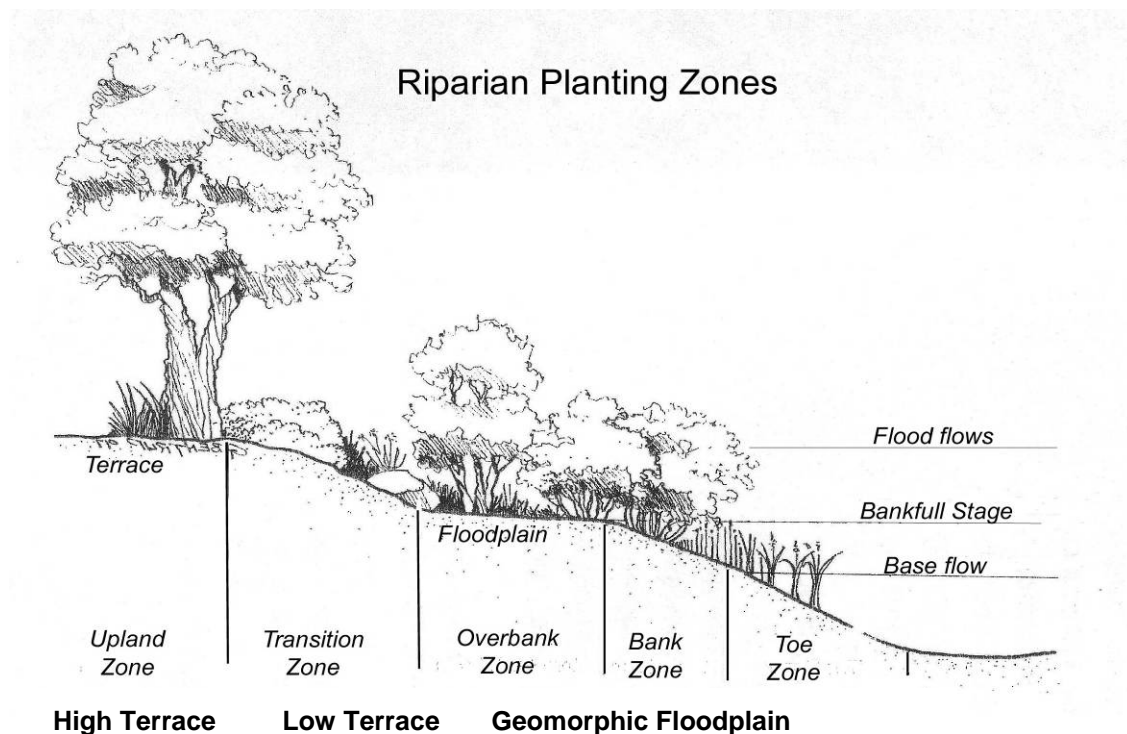
Figure 7 Riparian Planting Zones

Researchers at the NRCS Plant Materials Center in Idaho have divided the riparian corridor into discreet planting zones (Hoag, et al, 2001). Each zone supports a different community, complimenting stream processes and creating habitats (Figure 7). For example, the Toe zone adjacent to the perennial flow supports lush, wetland plants; the Bank and Overbank zones are dominated by grasses and shrubby willows; and the Transition zone supports more arid grasses, shrubs and trees. The stiffness of vegetation (and associated roughness) generally increase as one moves away from the central stream channel. In the Master Plan the Toe, Bank, and lower Overbank zones belong in the Geomorphic Floodplain. The higher Overbank Zone is found in the Low Terrace. The High Terrace includes the Transition and Upland Zones.

Riparian vegetation grows in distinct bands or zones that lie parallel to the stream channel. The zones are defined by differing soil moisture and levels of disturbance.

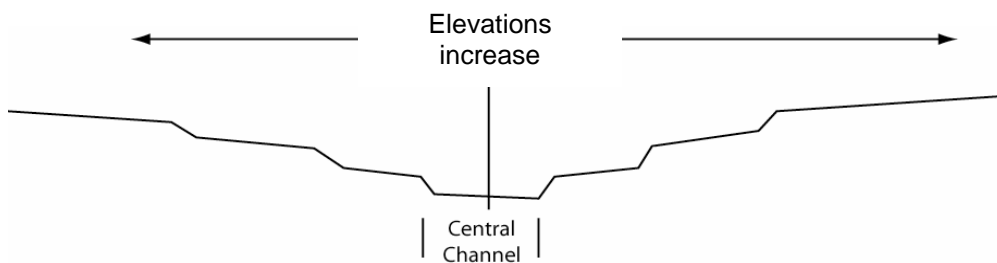
Figure 8 Appropriate channel/floodplain elevations

The central channel flowline must be the lowest point across the riparian area and the channel banks, floodplains, and terraces should slope upward continuously away from the channel. The banks will be most stable if they can be stepped as they rise away from the channel (Figure 8). For the Virgin River steps of approximately 4.0 feet are recommended. Slopes at these steps should be 3:1 or flatter. All flat areas should slope toward the river. If they are level or slope away from the river they will tend to divert overbank flows away from the main channel and could contribute to greater erosion (Figure 9). Banks on the outside of meanders are expected to rise more rapidly than those on the inside but should still be stepped if at all possible.

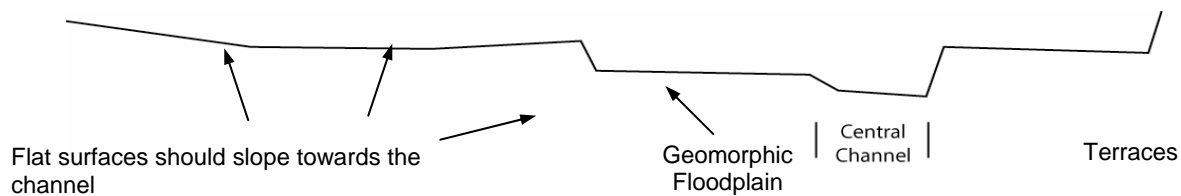
In this example, overbank areas are not sloped toward the central channel. Flow that overtops these banks may be trapped away from the channel and create erosion along the surfaces or gullies as the flow reenters the channel downstream.

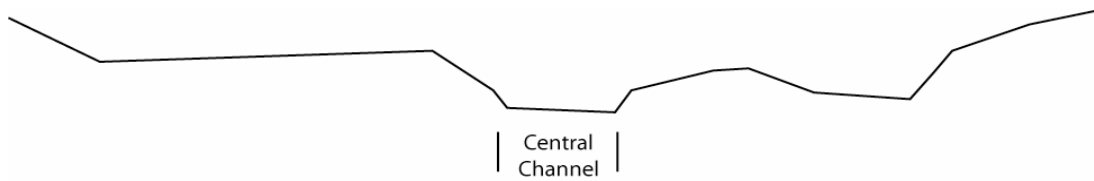
In this example, a secondary channel to the right may capture the main flow and increase erosion along that bank. Overflow channels can provide important “safety valves” for spreading flows but must be well vegetated (generally more thickly vegetated than the central channel) and reconnect to the main channel.

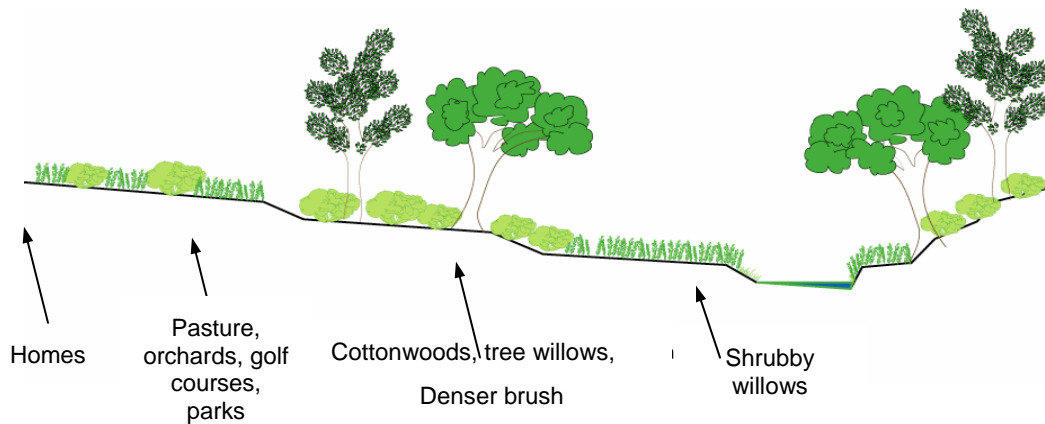
Figure 10 Appropriate overbank roughness.

Vegetation provides increasing roughness to keep high velocities in central channel.

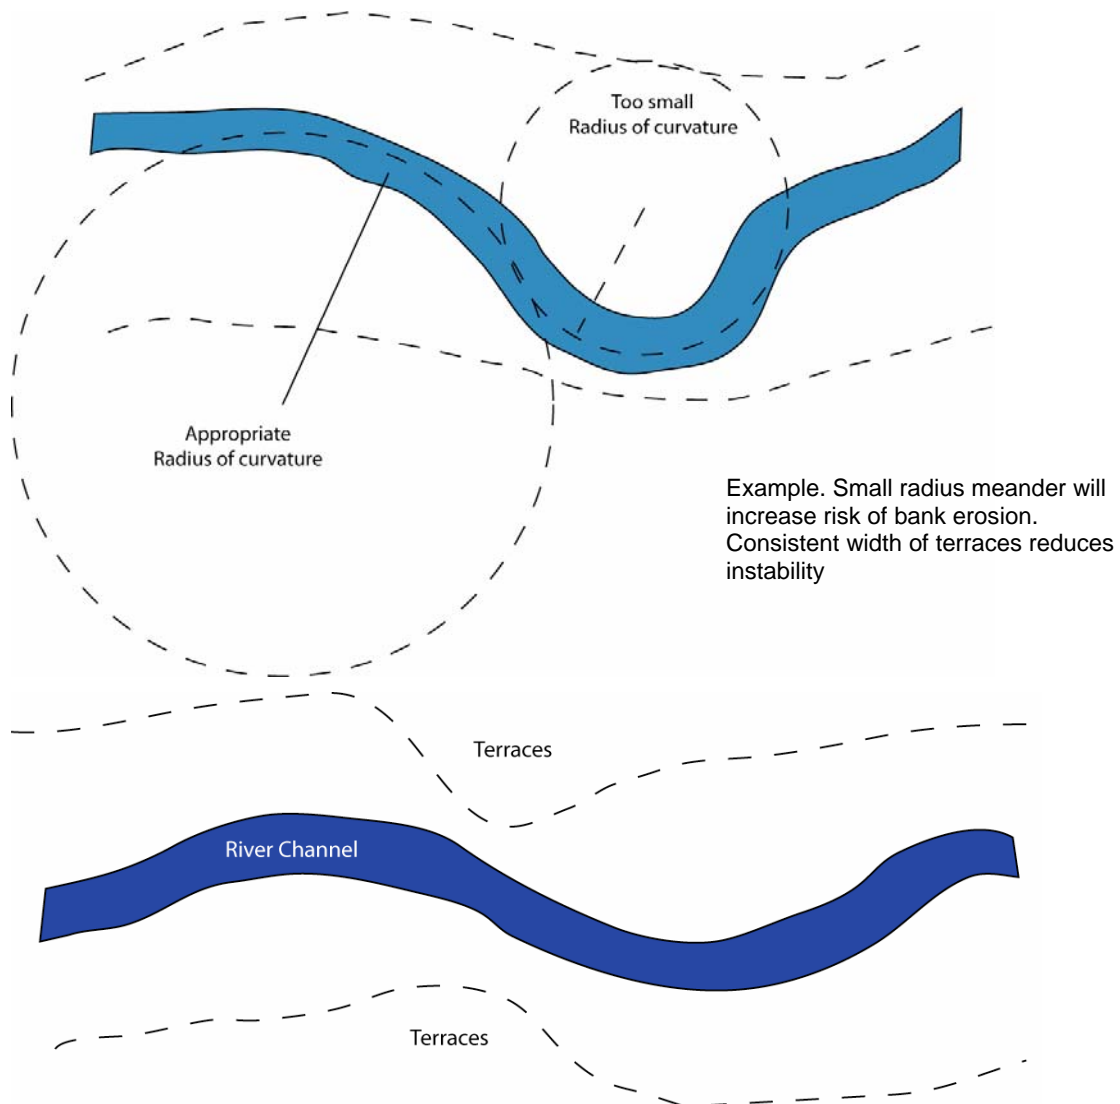
Figure 12 Incorrect channel transitions.

In order to minimize the risk of lateral bank erosion, water should flow smoothly through the stream corridor. While meander is a natural part of stream processes, tight turns can create excessive pressure to weak stream banks and increase erosion. Meanders should be gradual and within the dimensions described in specific recommendations. Floodplains and terraces should not be suddenly narrowed by buildings or other structures (Figure 12). Such constrictions force increases in velocity and water elevations that can increase erosion.

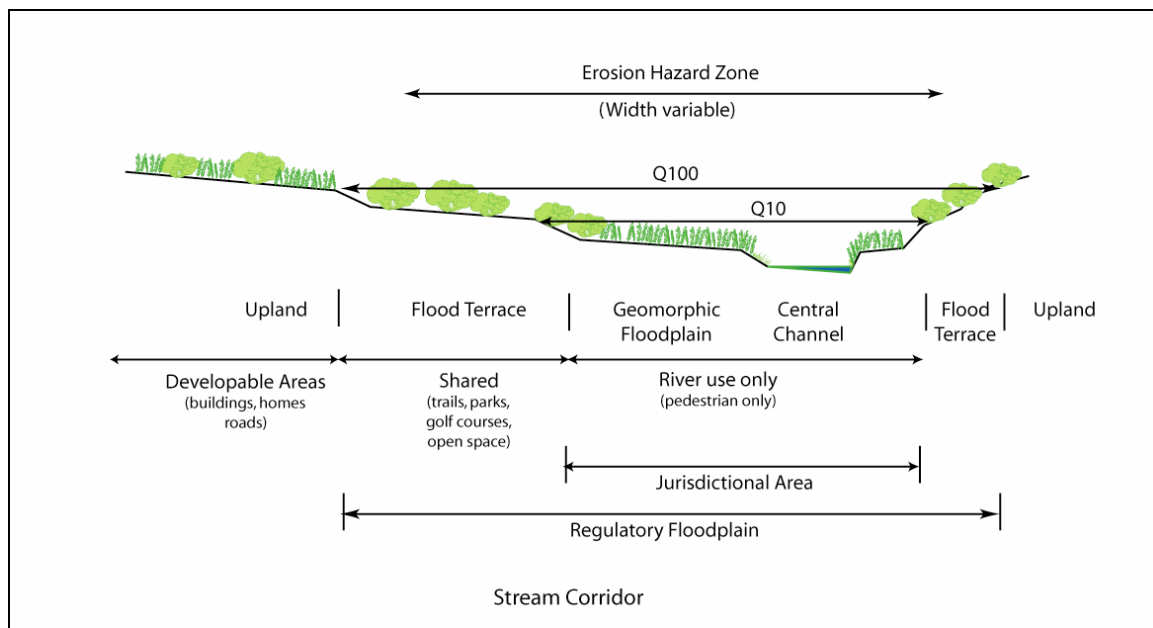
Figure 13 Stream corridor zones

Riparian Corridor Zones	Regulatory Issues	Approximate Width	Flood Protection	Vegetation	Uses
Central channel/ Geomorphic Floodplain	USACE Jurisdictional Area	360 ft	< 10-year	Native riparian willows, cottonwoods *	Pedestrian only, trails, no other improvements
Flood Terrace	FEMA Regulatory Floodplain	350 - 700 ft	< 100-year	Native xeric species, others with irrigation	Trails, parks, nurseries, golf courses, constructed wetlands
Flood Terrace	Erosion Hazard Boundary	Variable	> 100-year	Variable	Developable with engineered protection
Uplands	Development ordinances	> 700 ft	> 100-year	Landscaping	Fully developable Unless in EHZ

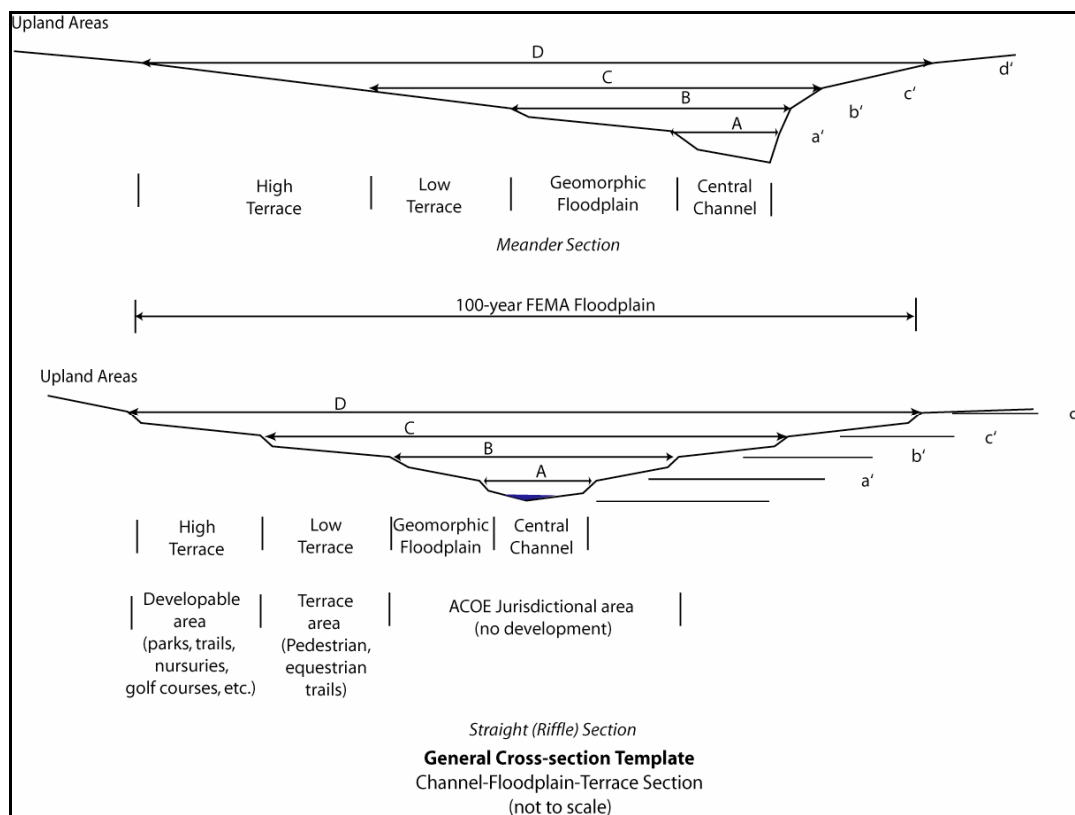
Figure 14 Cross-section template

*** Top width is dependent on design width depth ratio

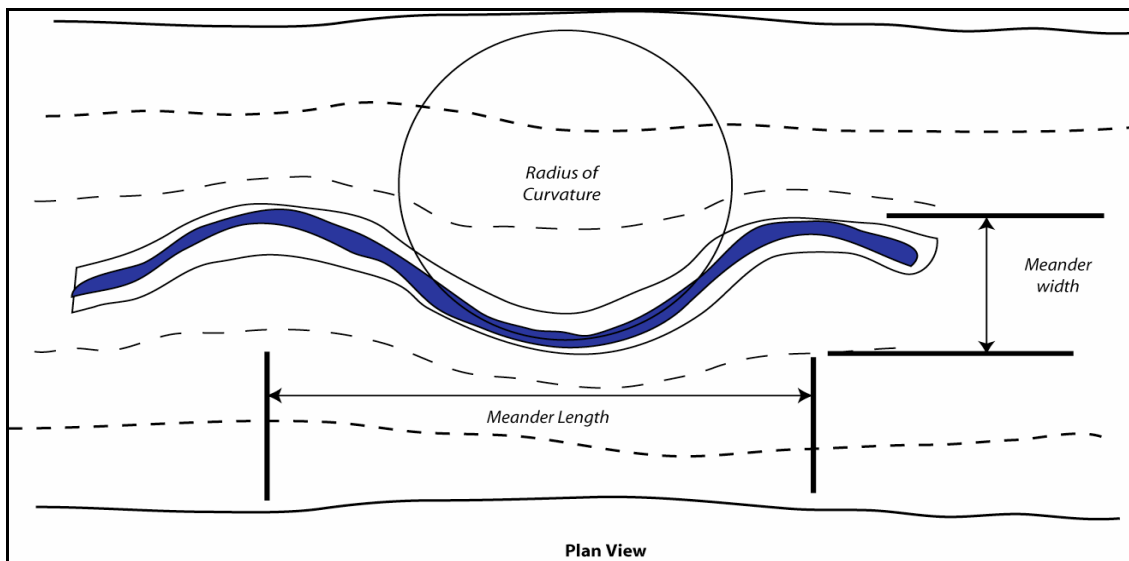
Figure 15 Meander pattern characteristics

Radius of Curvature	Meander length	Meander width
	(feet)	(feet)	(feet)
Maximum	708	1660	606
Average	552	1,491	530
Minimum	424	1200	400

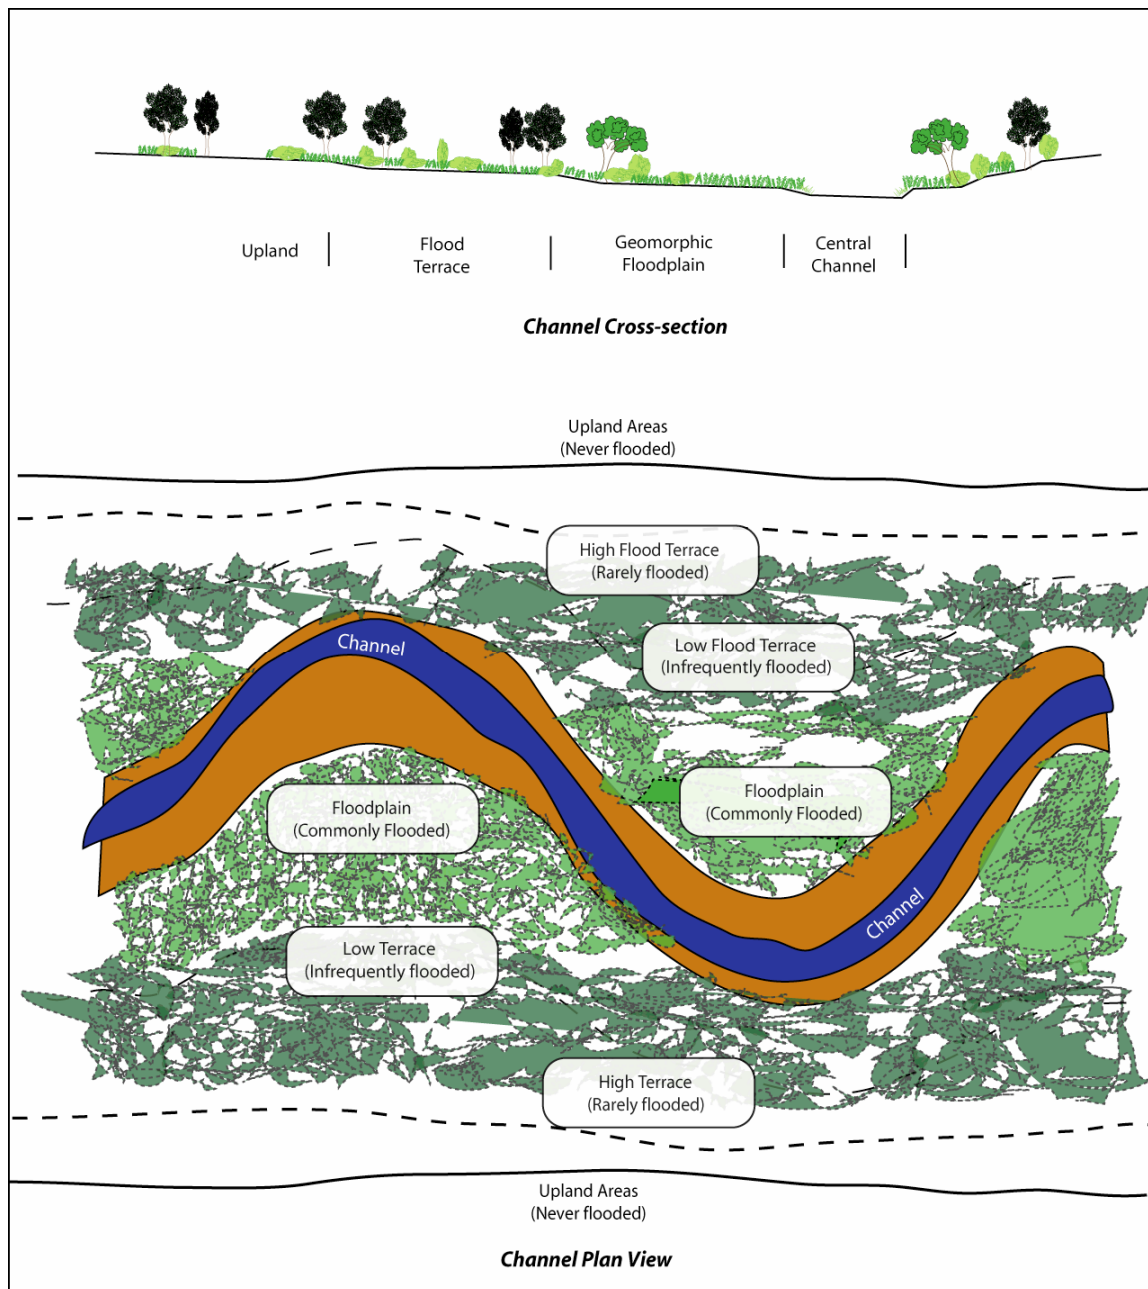
Figure 16 Areas of re-vegetation

Geomorphic Floodplain/ Low Flood Terrace: Supple woody species including willow and baccharis species should be placed in areas immediately adjacent to the channel. Stiffer shrubs and trees can be planted in higher areas. Vegetation composition should be carefully integrated with human uses to maintain resistance to flow (roughness) as described in the guiding principles. Due to their inability to endure high soil salinity, the establishment of willow and cottonwood species will be dependent on the local soil conditions.

High Flood Terrace/Upland Areas: High flood terraces can support a wide variety of native and cultivated vegetation depending on the use but will generally require irrigation. In addition, if the vegetation cover is sparse with relatively low resistance to flow, revegetation guidelines including the installation and maintenance of hedgerows or low berms aligned at right angles or angled downstream to the stream flow to provide increased resistance to flow across these surfaces. Levees or hedgerows should never be placed parallel to stream flow. Bare ground should be avoided.

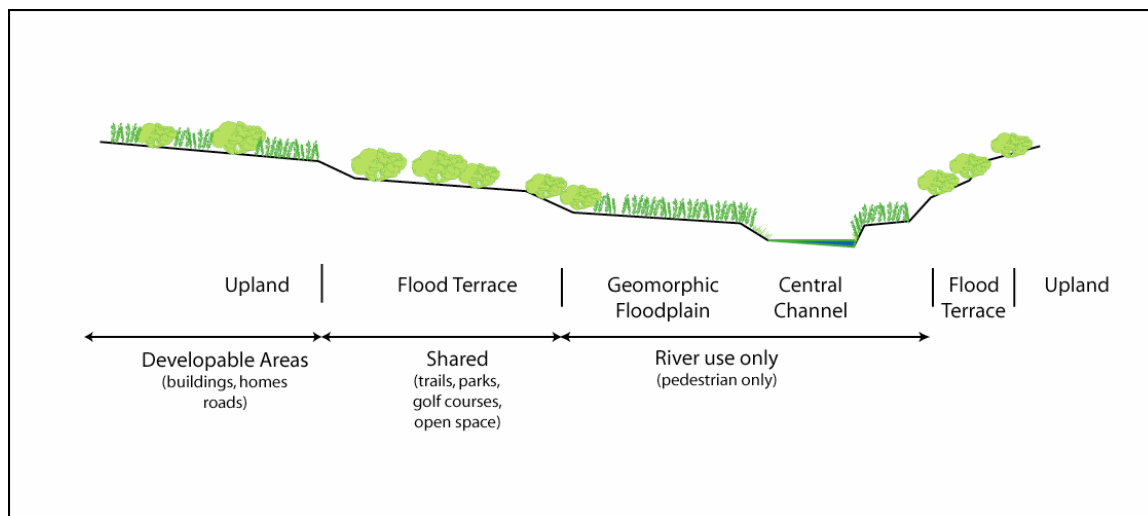
Figure 17 Appropriate land uses.

Rivers flood. Common floods inundate areas closest to the central channel; higher, less frequent floods affect higher areas. In terms of use, riparian corridors can be divided into four zones (Figure 17). The first and second are the lowest in elevation and include the central channel and adjacent floodplain. This area is flooded frequently and sometimes for long periods of time. While it can be used for passive activities such as hiking and birding, alterations to this area can severely impact the essential processes of the stream. This area should be thought of as belonging entirely to the river.

The second area includes the low and high terraces and bars above the flood plain. These areas are inundated by Moderate and High floods but can be used for parks, agricultural fields, and recreational areas. This common area can be used by both the river and humans. Flooding will periodically scour areas and deposit sediments but damage should be manageable. No permanent structures should be constructed in these areas. Structures can constrict and/or redirect flows destabilizing the stream and creating additional flooding and erosion risks.

The final area includes lands that are above the level of all river flooding. These areas belong to humans and can contain houses and other permanent structures.

Human uses vary on these alluvial surfaces depending on the risk of flooding. The following are recommended uses for each.

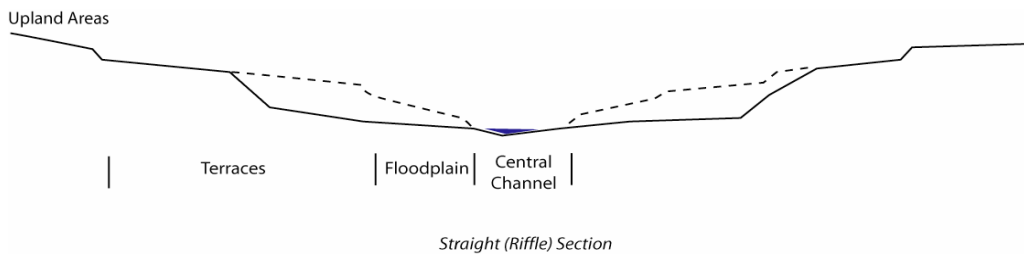
Figure 18 Channel excavation

If needed to increase conveyance, channel excavations should follow dotted line in this graphic preserving the alluvial forms critical to sediment transport.

Should excavation be warranted, channel/floodplain/terrace dimension should be maintained (Figure 18). Lowering geomorphic floodplain and terrace elevations will lead to an overwidened channel (Figure 19). An over-widened channel reduces sediment transport and increases deposition. The result can be a reduction of flow capacity below initial conditions. In addition, over-widening the channel often accelerates lateral channel migration and increased bank erosion. All excavations should be consistent with the guiding principles; i.e., the floodplain/terrace should rise as it moves away from the channel and roughness should increase away from the channel (Figure 20). Eventually coyote willow or other supple native woody species should be planted where the tamarisk is removed.

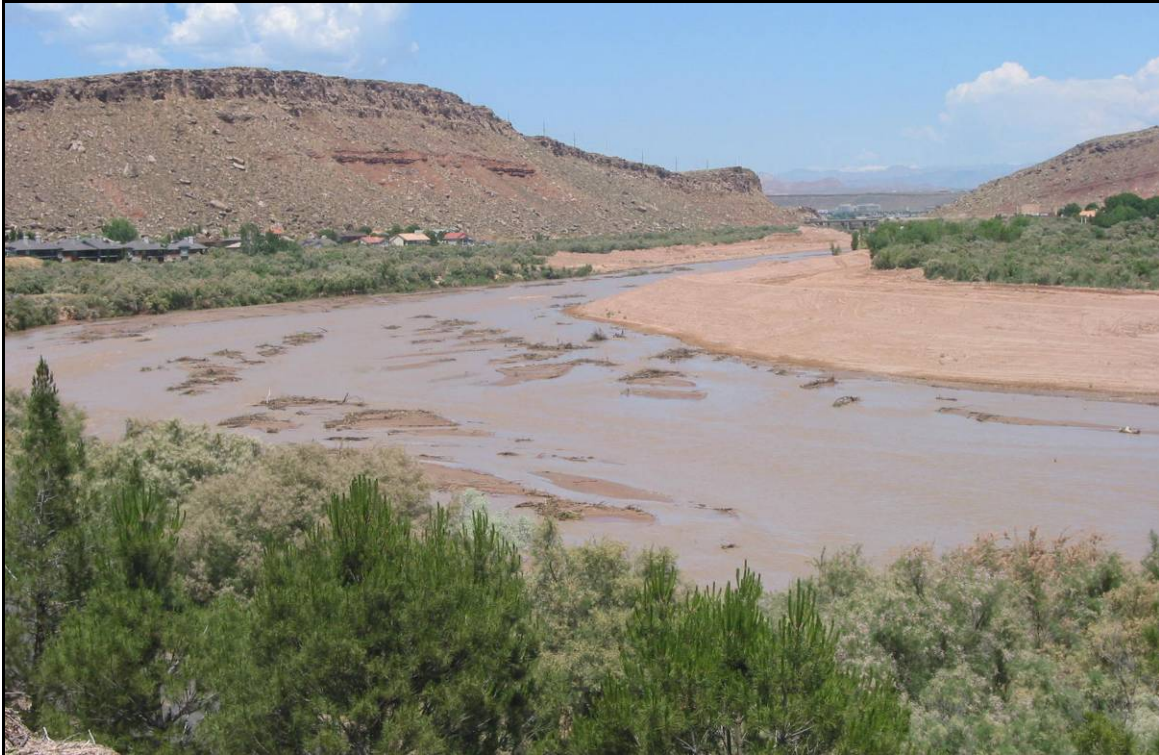
Figure 19 Over-widened channel excavations

Excavations to increase conveyance have removed all alluvial features and associated riparian vegetation decreasing sediment transport and increasing the risk of lateral erosion.

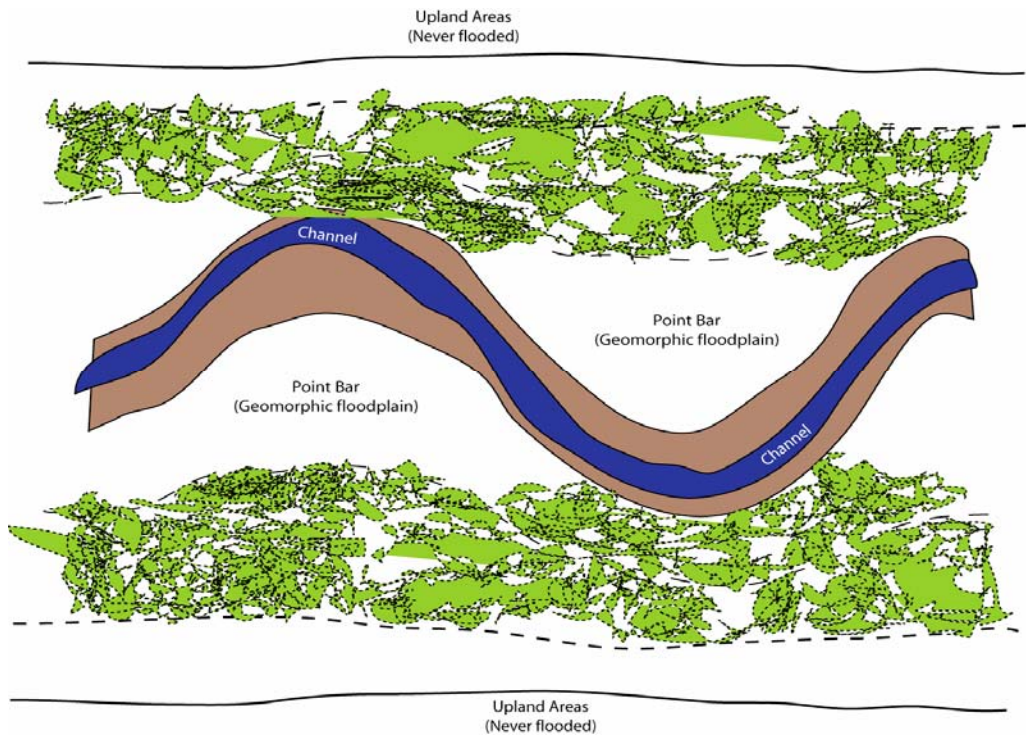
Figure 20 Channel excavation areas.

*To increase flow conveyance, dense thickets of salt cedar and other exotic species may be removed from point bar areas. Willows and other native vegetation should **not** be removed. Disturbed areas should be replanted with native vegetation.*

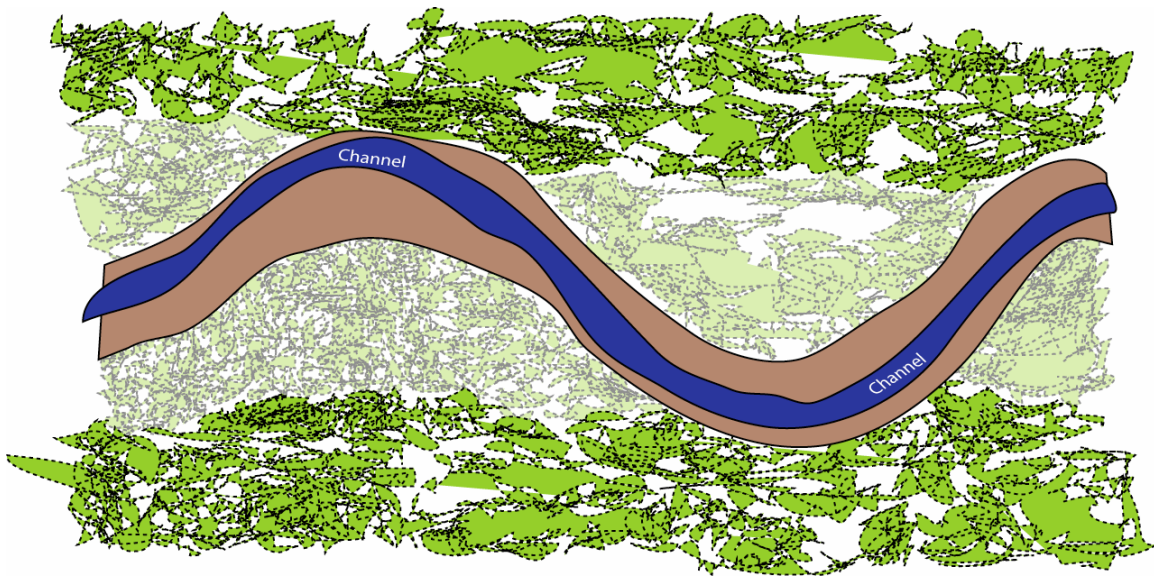
Figure 21 Exotic species removal: Stage I.

Initial removal of salt cedar should be in areas adjacent to the active channel. Point bars on the inside of meander bends are prime candidates. These areas have higher soil moisture levels and a disturbance regime that will benefit the native species.

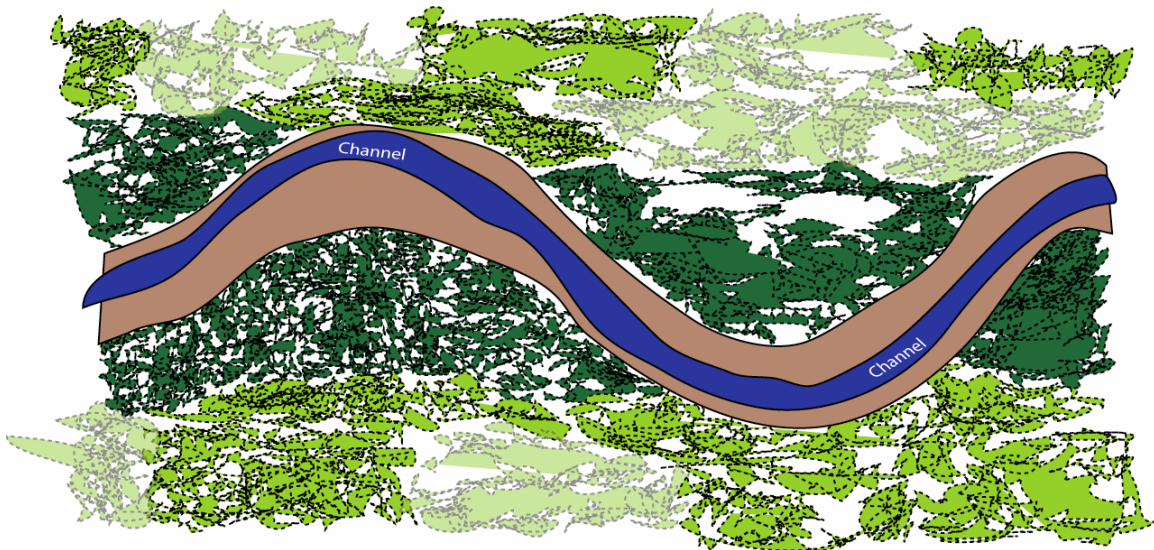
Figure 22 Exotic species removal: Stage II.

Once native riparian vegetation has become sufficiently established to resist flow velocities, non-continuous patches of vegetation should be removed from floodplains and terraces and replanted with native species. Irrigation may be necessary to speed establishment. Manual removal and herbicide application may be necessary to limit recruitment of salt cedar in re-vegetated areas.

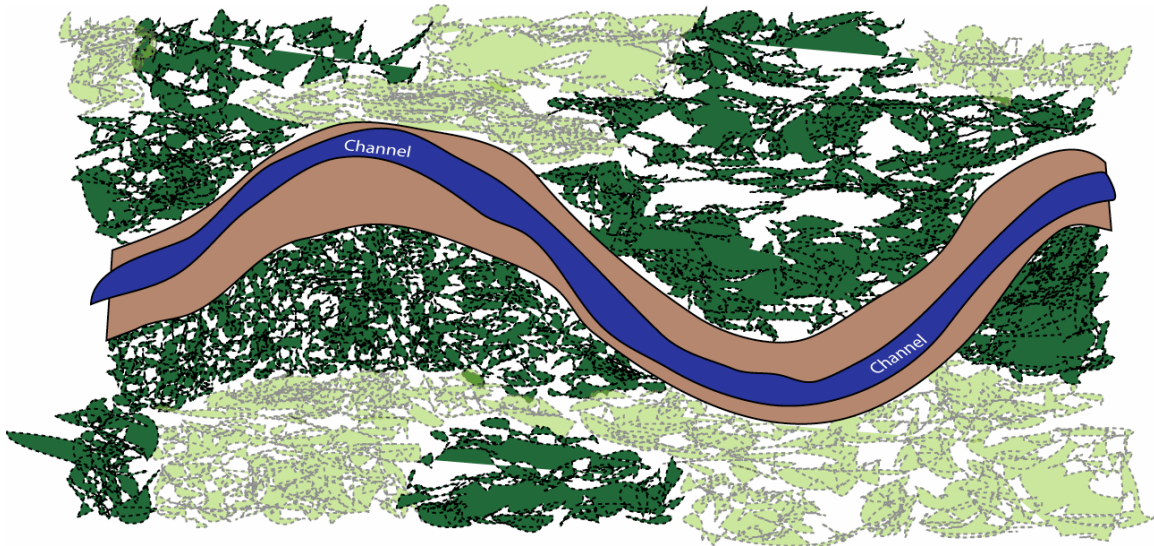
Figure 23 Exotic species removal: Stage III.

When native vegetation has been established, remove more discontinuous patches of exotic vegetation and replant with natives. Manual removal and herbicide application may be necessary to limit recruitment of salt cedar in revegetated areas.

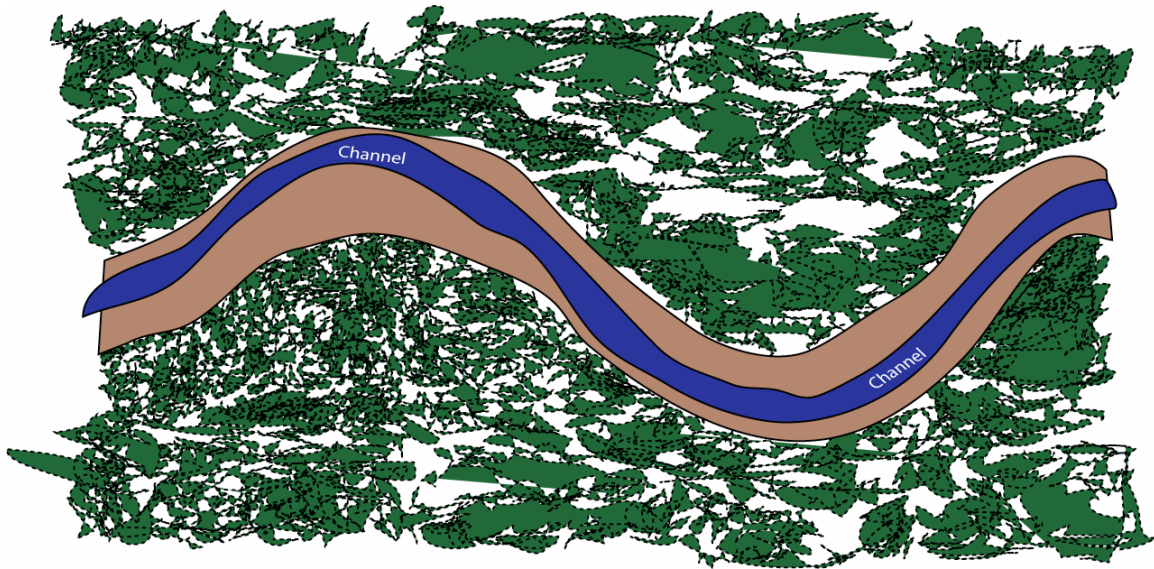
Figure 24 Exotic species removal: Stage IV.

Complete revegetation. Manual removal and herbicide application may be necessary to limit recruitment of salt cedar in revegetated areas. A thin band of salt cedar at the outer edge of the corridor may provide additional erosion protection.

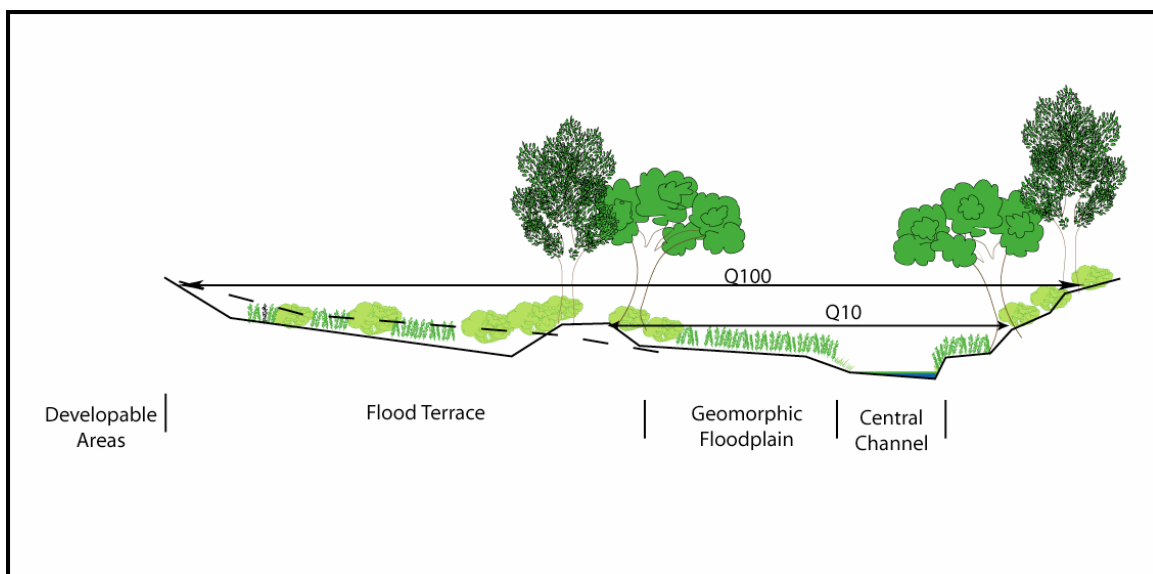
Figure 25 Overbank flow separation

Overbank flows can result in damage to properties from flooding, erosion, and/or sediment deposition. Flooding is the most well-known and least destructive. Second, concentrated overbank flows with high velocities can be very erosive. In extreme cases, the separated overbank flows can erode new channels and “capture” the main flow (Figure 25). This was the cause for much of the property damage along the Santa Clara River in the January 2005 flood. Secondly, overbank flows often carry significant fine sediment loads. If the flows are separated from the main flow spread and/or pond, the lack sufficient velocity will result in the deposition of sediments. The Sun River golf course provided a good example during the 2005 flood.

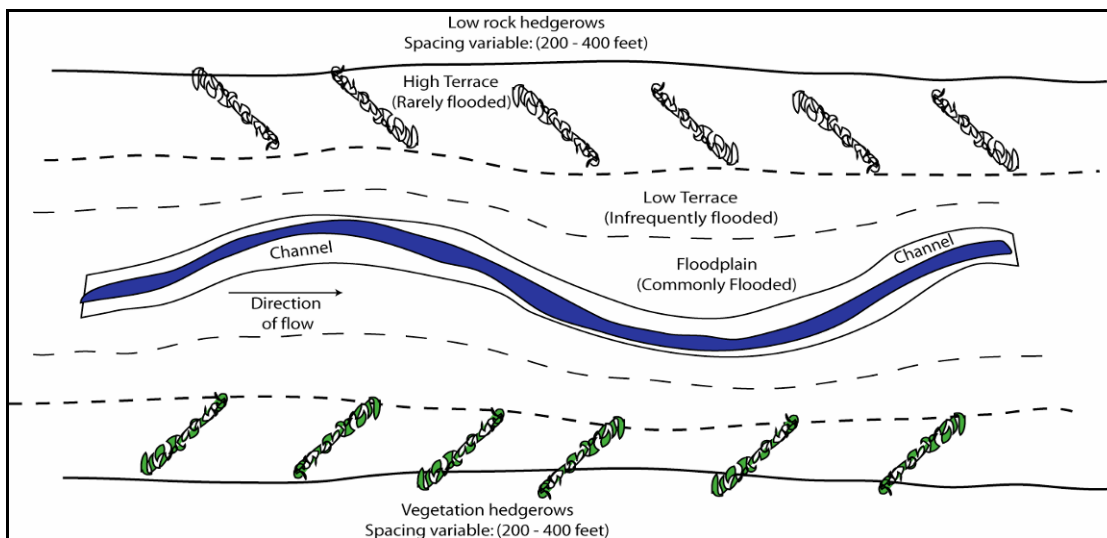
Figure 26 Terrace stabilization strategies

Erosion can be created by high velocity flows on the high overbank areas and separated from the central stream channel. Many of these areas will be used for recreational parks, golf courses, or agricultural fields and will not have dense, continuous vegetation. On the other hand low velocity flows stranded on terrace features can deposit substantial volumes of sediment. In order to increase roughness and redirect overbank flows toward the central channel, series of hedgerows can be constructed periodically along the terraces. These hedgerows can be created using low rock levees or well-rooted, stiff woody plant species. They can be installed perpendicular or angled downstream (Figure 26). Hedgerows, dikes, or other structure should never be constructed in continuous sections parallel to the stream flow because they will reduce the ability for overbank flows to return to the river.
