Landowners Handbook

**A road map for reconstruction,
management, and long-term maintenance**

Virgin River

Washington County, Utah

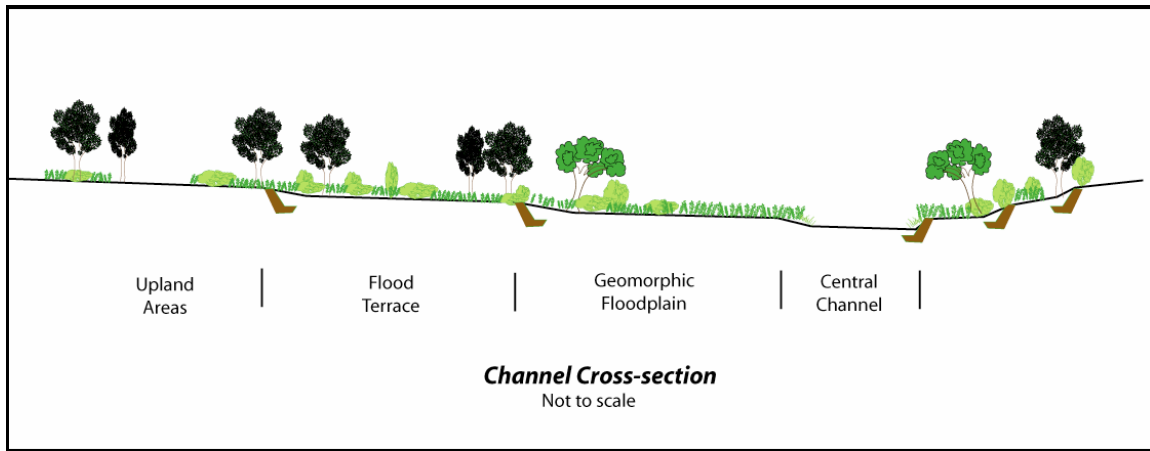
Figure 27 Bank stabilization strategies

Bank stabilization may be needed when the active channel has migrated adjacent to properties or to the edge of the Erosion Hazard Zone. Due to the high magnitudes of Virgin River floods, structural measures will generally be needed to protect eroding banks. Rock size, angle, and scour depth of all structural practices should be carefully engineered to withstand the depths and velocities of the design flood stage. The integration of bioengineering practices with the structural will increase the protection and provide additional habitats. Appropriate channel cross-section dimension/elevation and pattern should also be considered to reduce hydraulic forces against the bank (Figure 27).

Lateral migration protection should not be confused with flood control. Bank protection can be installed at any point within the riparian corridor depending on specific objectives. However, the structural protection should not extend above the elevation or interfere with overbank flows onto the associated feature (channel, geomorphic floodplain, flood terrace).

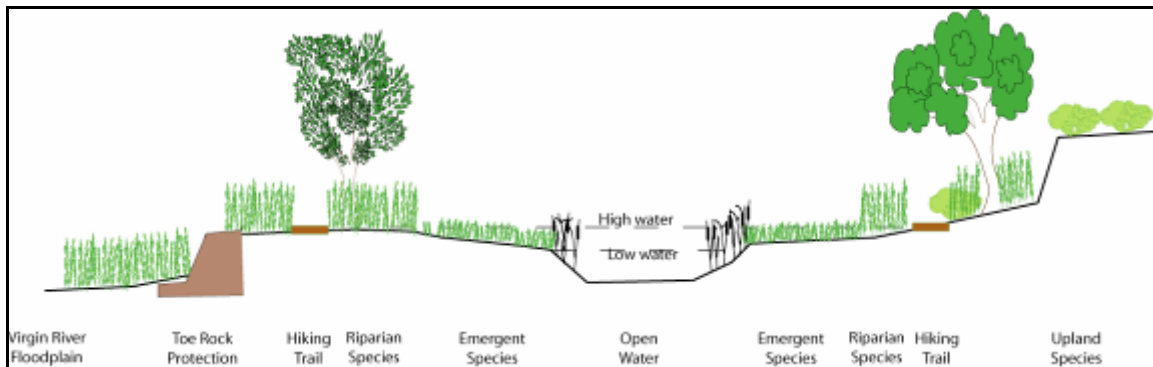
Figure 28 Typical design marsh/trail/rock cross-section

Marsh and surrounding riparian areas should provide a complex and diverse mixture of plant communities. Each community is dependent on different soil moistures dictated by topography and depth to groundwater. Trails and other amenities can be easily incorporated into the design.

A good example of this opportunity is Seegmiller Marsh located in Reach 4. This marsh area has naturally formed in the abandoned meander scars of the Virgin River. Agricultural return flows support perennial water. Careful design of the marsh or management of its hydrology can create a variety of rare habitats (Figures 28 & 29).

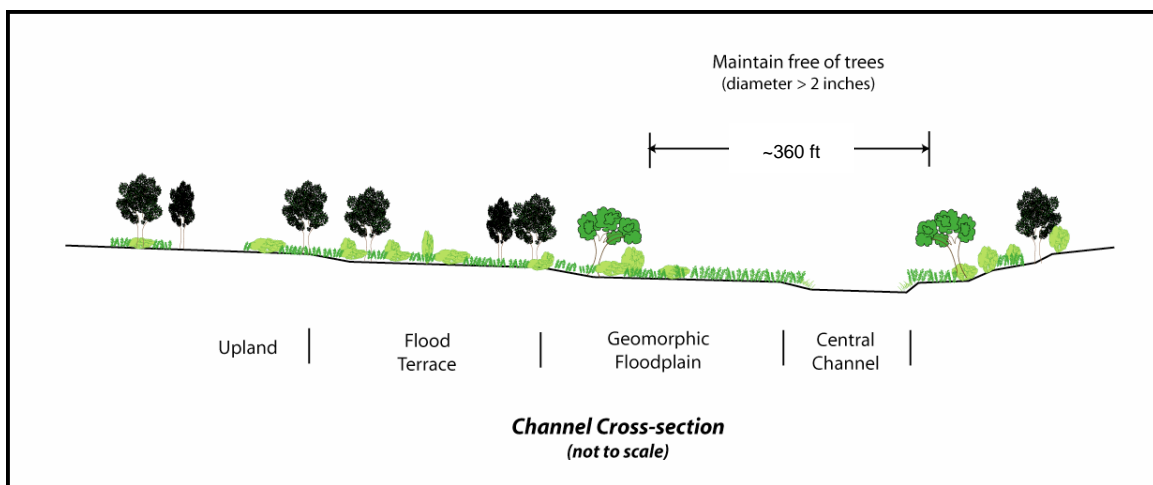
Figure 30 Channel maintenance

Long-term stability depends on maintaining a clear channel. Large stiff woody species such as salt cedar, cottonwood, or willows should not be allowed to colonize the central channel areas. These species should be removed when they reach a diameter at breast height (DBH) of 2 inches.

Following large flood events, the dimension, pattern, and profile of areas with significant erosion should be restored in accordance with the Master Plan stability template.

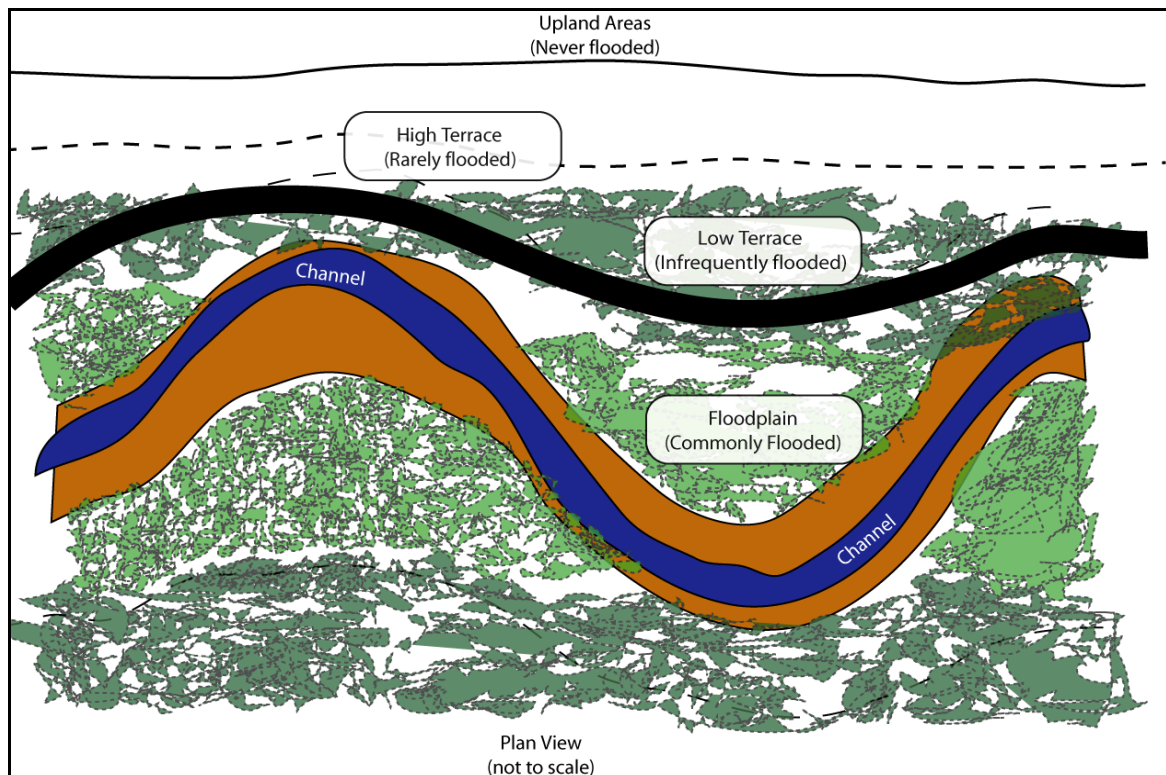
Figure 31 Pedestrian trail; plan view

- Trails should be located above the 10-year flood risk to minimize maintenance.
- Trails should wind close to and away from the river channel to discourage capture of overbank flows (Figure 31).
- Trails should vary in elevation between the 10-year and higher flood stages to discourage erosive high velocity flows from capture of overbank flow capture (Figure 32).

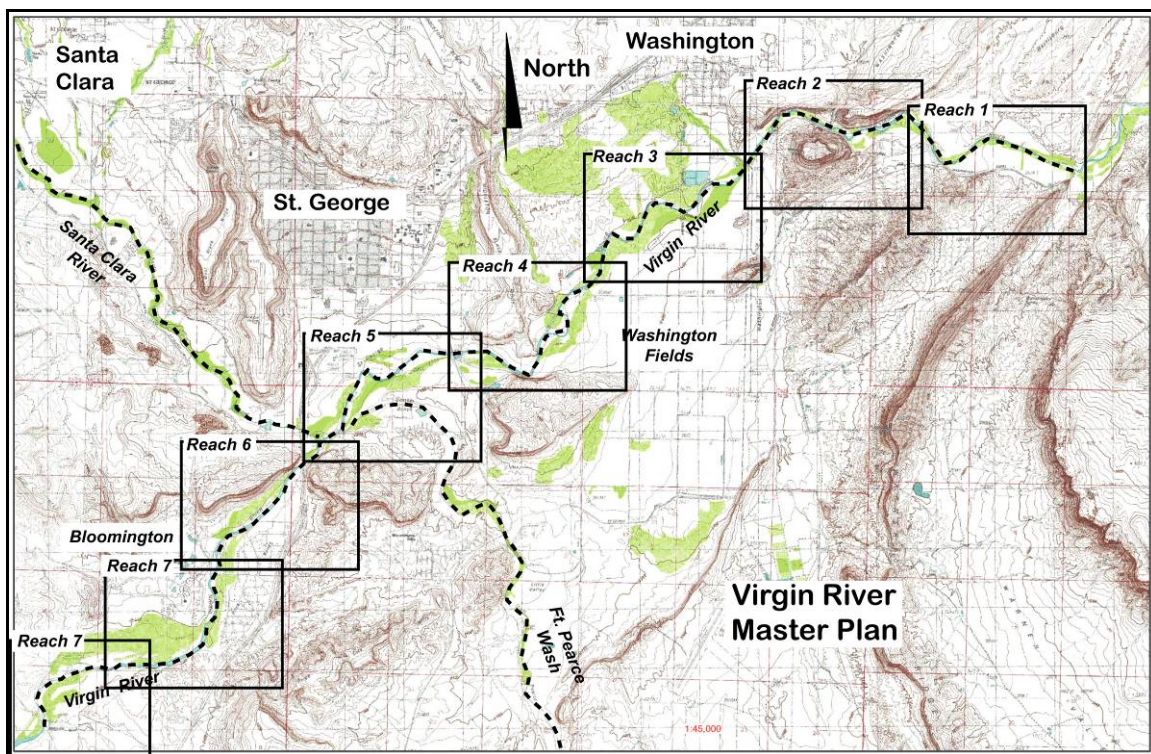
Figure 33 Index to reach maps

This section describes areas of concern and provides specific recommendations for each project reach (Figure 33). Locations of stormwater drains were from GIS coverage supplied by St. George and Washington cities. Potential wetland areas were based on field observations and comments provided by resource agency staff.

NRCS levee locations are based on field observations in the fall of 2006 and locations should be considered approximate. Additional bank protection may be installed subsequent to this report. It should be remembered that the NRCS dikes were placed for erosion control rather than flood control. They may still be overtopped during extreme flood events.

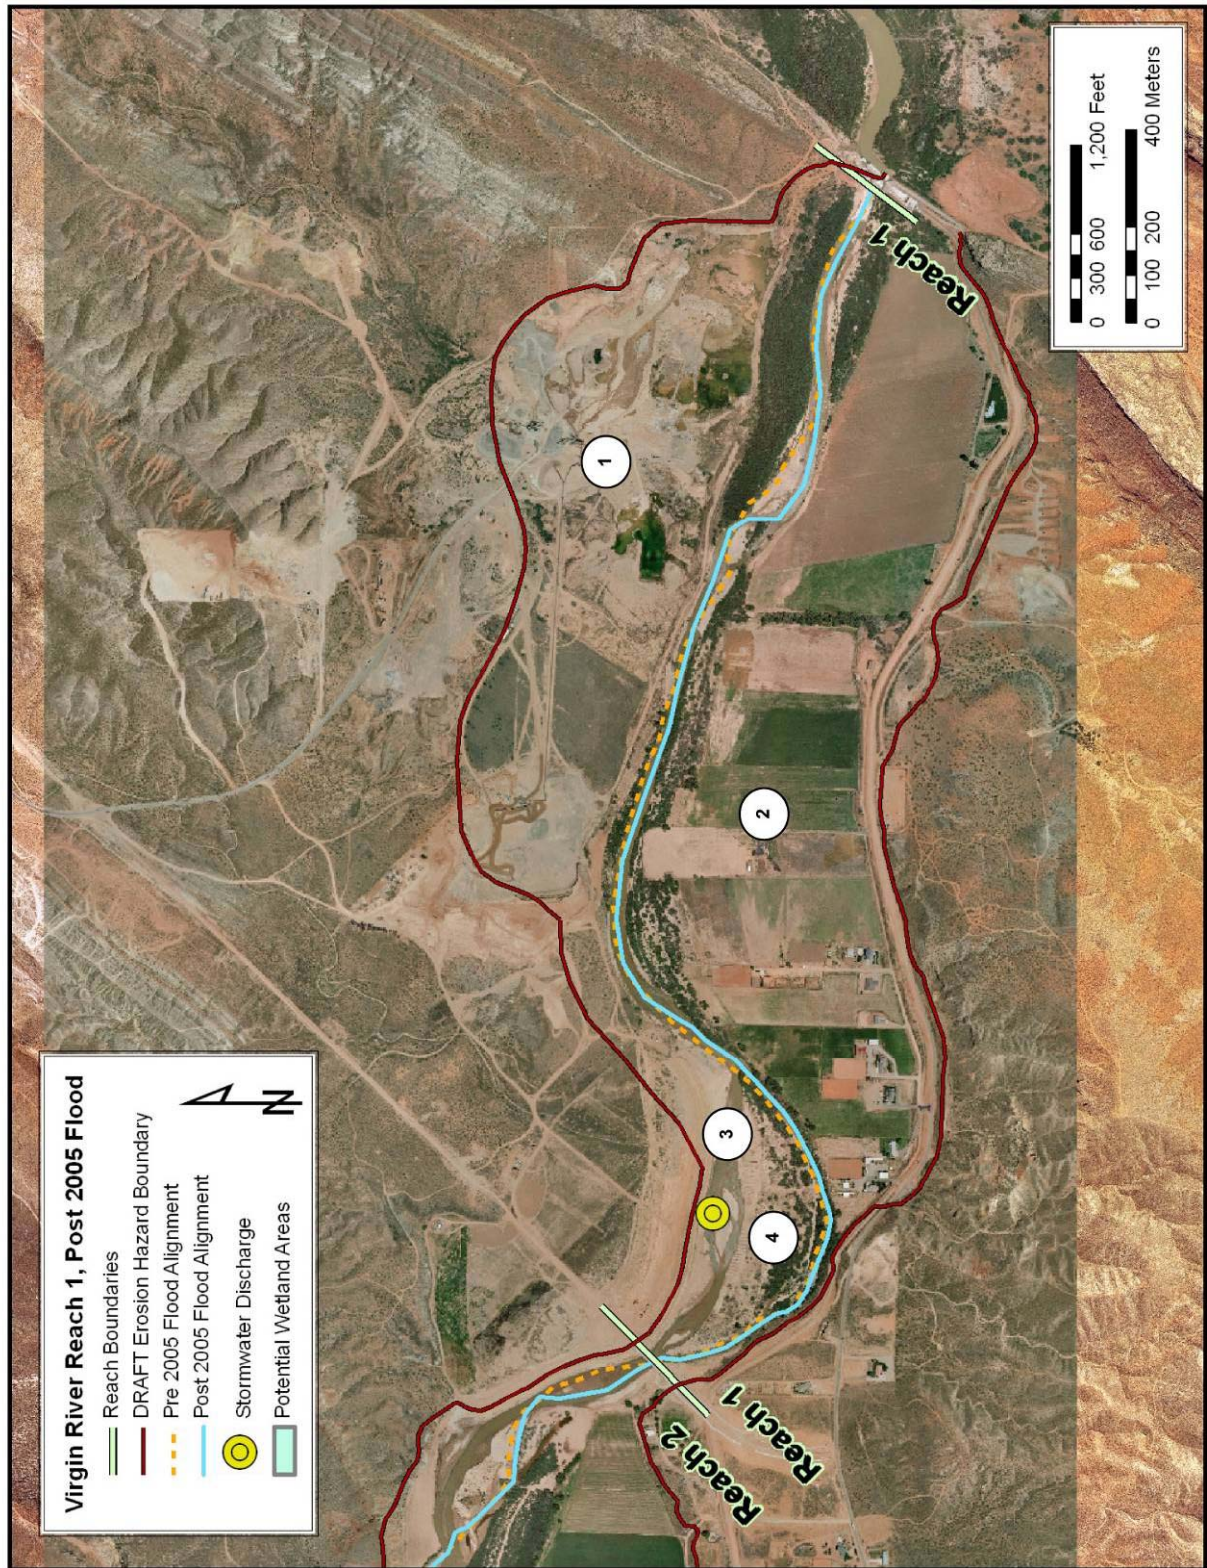
Figure 34 Reach 1 map

This reach includes the river between Washington Fields Diversion and Sunrise Valley Bridge (Figure 34). The river is relatively straight and undeveloped. Although the upstream sections are dominated by thick stands of salt cedar along one or both banks, it is mixed with considerable amounts of native vegetation. The reach appears relatively stable and changed little as a result of the 2005 flooding, however, the extreme width of the Erosion Hazard Zones (EHZ) increases the risk of large scale lateral channel movement. Existing and future sand and gravel mining operations can increase the chances of instability and post-mining rehabilitation should be carefully planned and executed. Future development of the agricultural areas on the south side of the river should be consistent with Master Plan recommendations.

1. Operation and rehabilitation of sand and gravel mining on north side of the river should be carefully planned and implemented.
2. If developed agricultural areas to the south should be consistent with Master Plan recommendations.
3. Existing point bars and floodplains upstream of the Sunrise Valley bridge should be left undeveloped to spread flood flows. Rock bank protection has been installed on the inside of this meander.
4. Thick invasive vegetation should be replaced by appropriate native species.

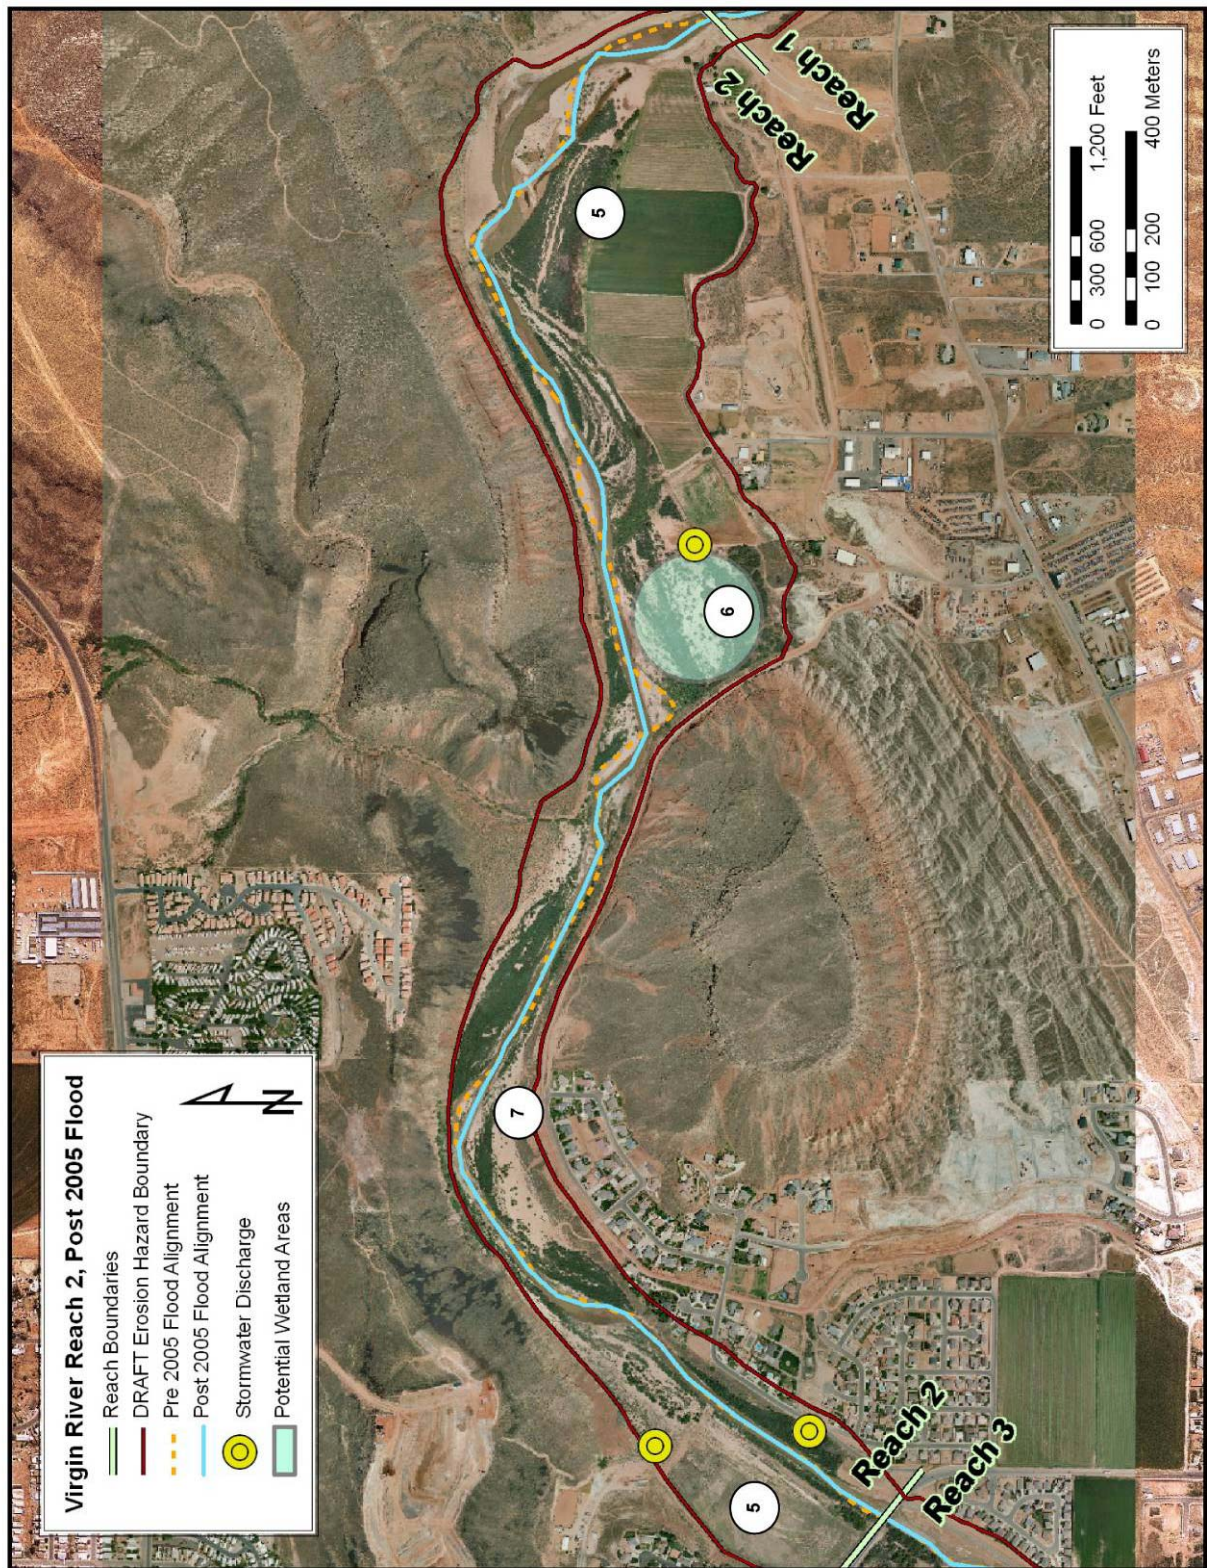
Figure 35 Reach 2 map

This reach includes the river from Sunrise Valley Bridge to the Washington Fields Road Bridge (Figure 35). Most of this reach lies within a relatively narrow bedrock valley with high quality native vegetation associated with small spring areas. Agricultural fields at upstream and downstream ends of the reach have potential for development. However, the EHZ is relatively wide in these areas increasing the risk of lateral channel movement. The narrow bedrock canyon is suitable for trails and other recreational amenities. An open area at the head of the canyon has potential for constructed wetlands for wildlife habitats and stormwater treatment.

5. If agricultural areas are developed planning should be consistent with Master Plan recommendations.
6. A large stand of relatively high quality native riparian plant community is located above the narrow valley and could provide a location for wetland creation and stormwater treatment.
7. Most of reach in narrow geologic control valley with little development potential, area is appropriate for trails.

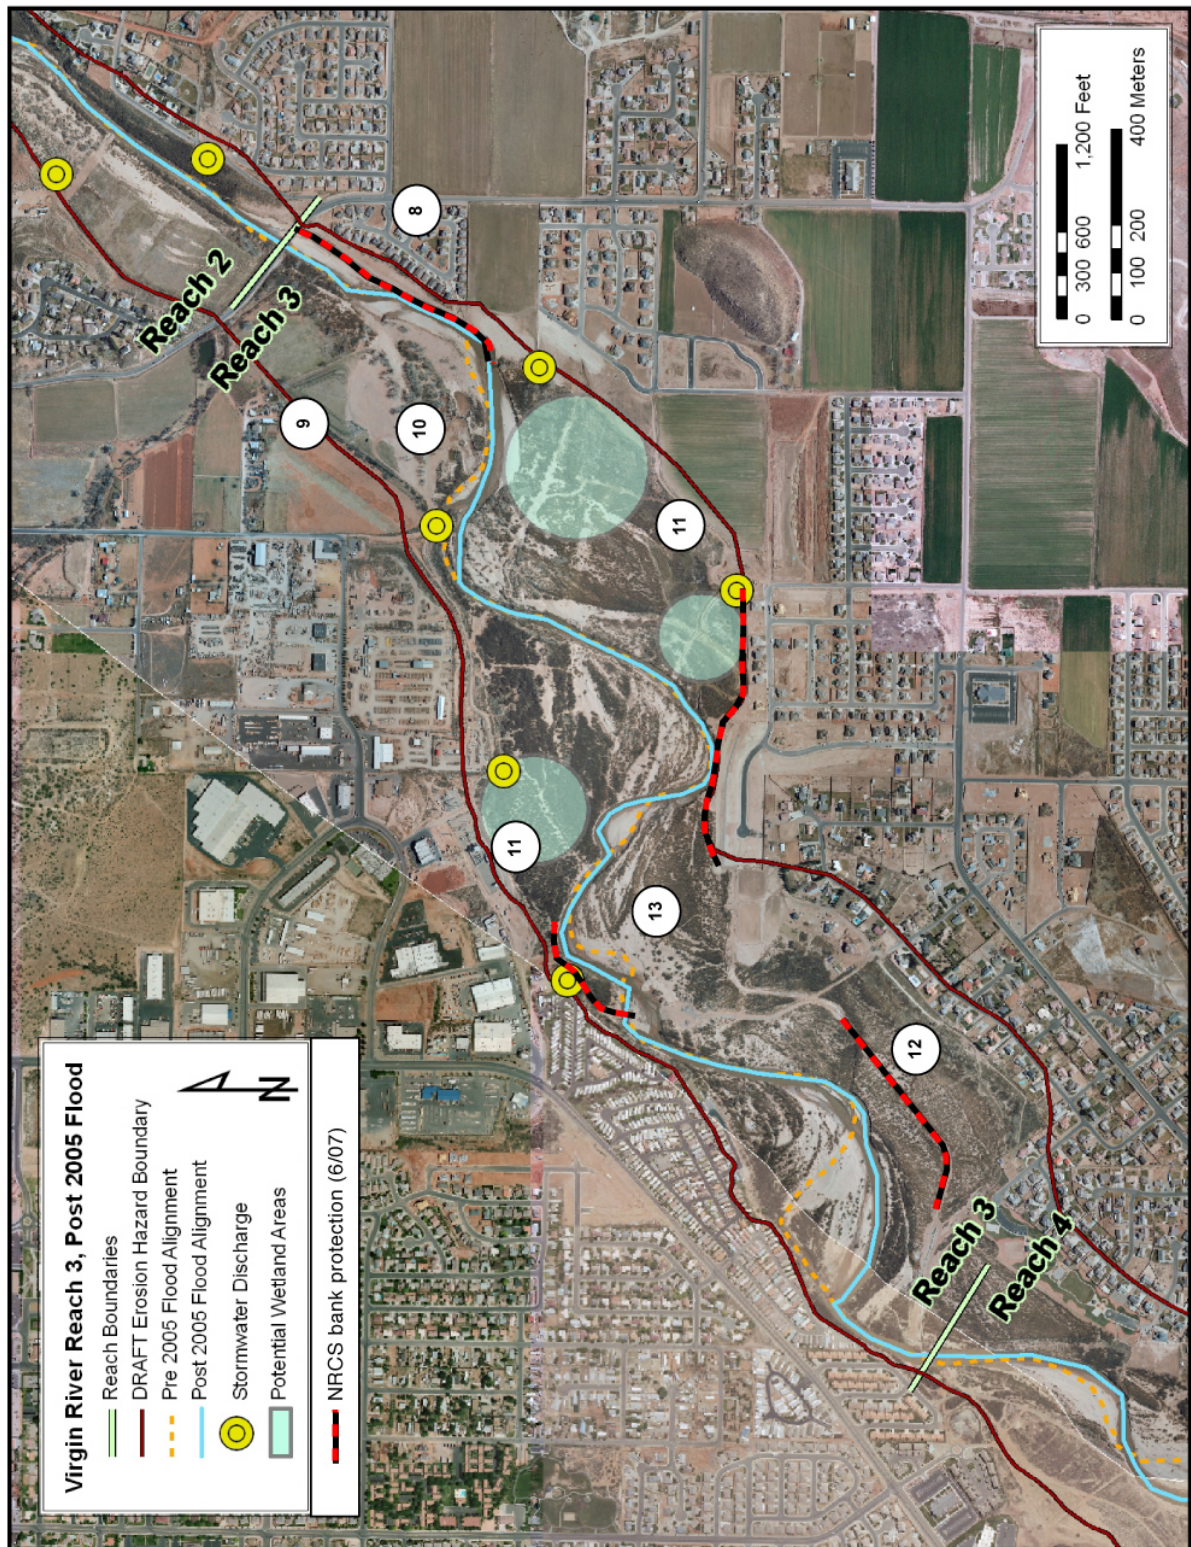
Figure 36 Reach 3 map

This reach includes the river from Washington Fields Drive bridge to the Johnson Diversion (Figure 36). The riparian corridor represented by the EHZ is relatively broad and old meander scars suggest that lateral channel movement is common in this reach. This meander is important to dissipating stream energy and should not be substantially narrowed. The broad corridor provides several areas suitable for habitat enhancement and stormwater treatment. NRCS bank protection is limited to short segments and, in some instances, may increase risk of property damage. Some existing housing lies within the EHZ and is at risk from erosion.

12. A short buried NRCS levee protects a waterline in this area. However, the levee does not extend to stable structure outside the EHZ. The levee has the potential to trap flows behind it increasing the risk of erosion to adjacent homes inside the EHZ. The lack of vegetation along the pipeline increases the risk of capture by the river. The structure should be extended to the edge of the EHZ.

13. Areas of thick salt cedar should be replaced by appropriate native species especially adjacent to the active stream channel.

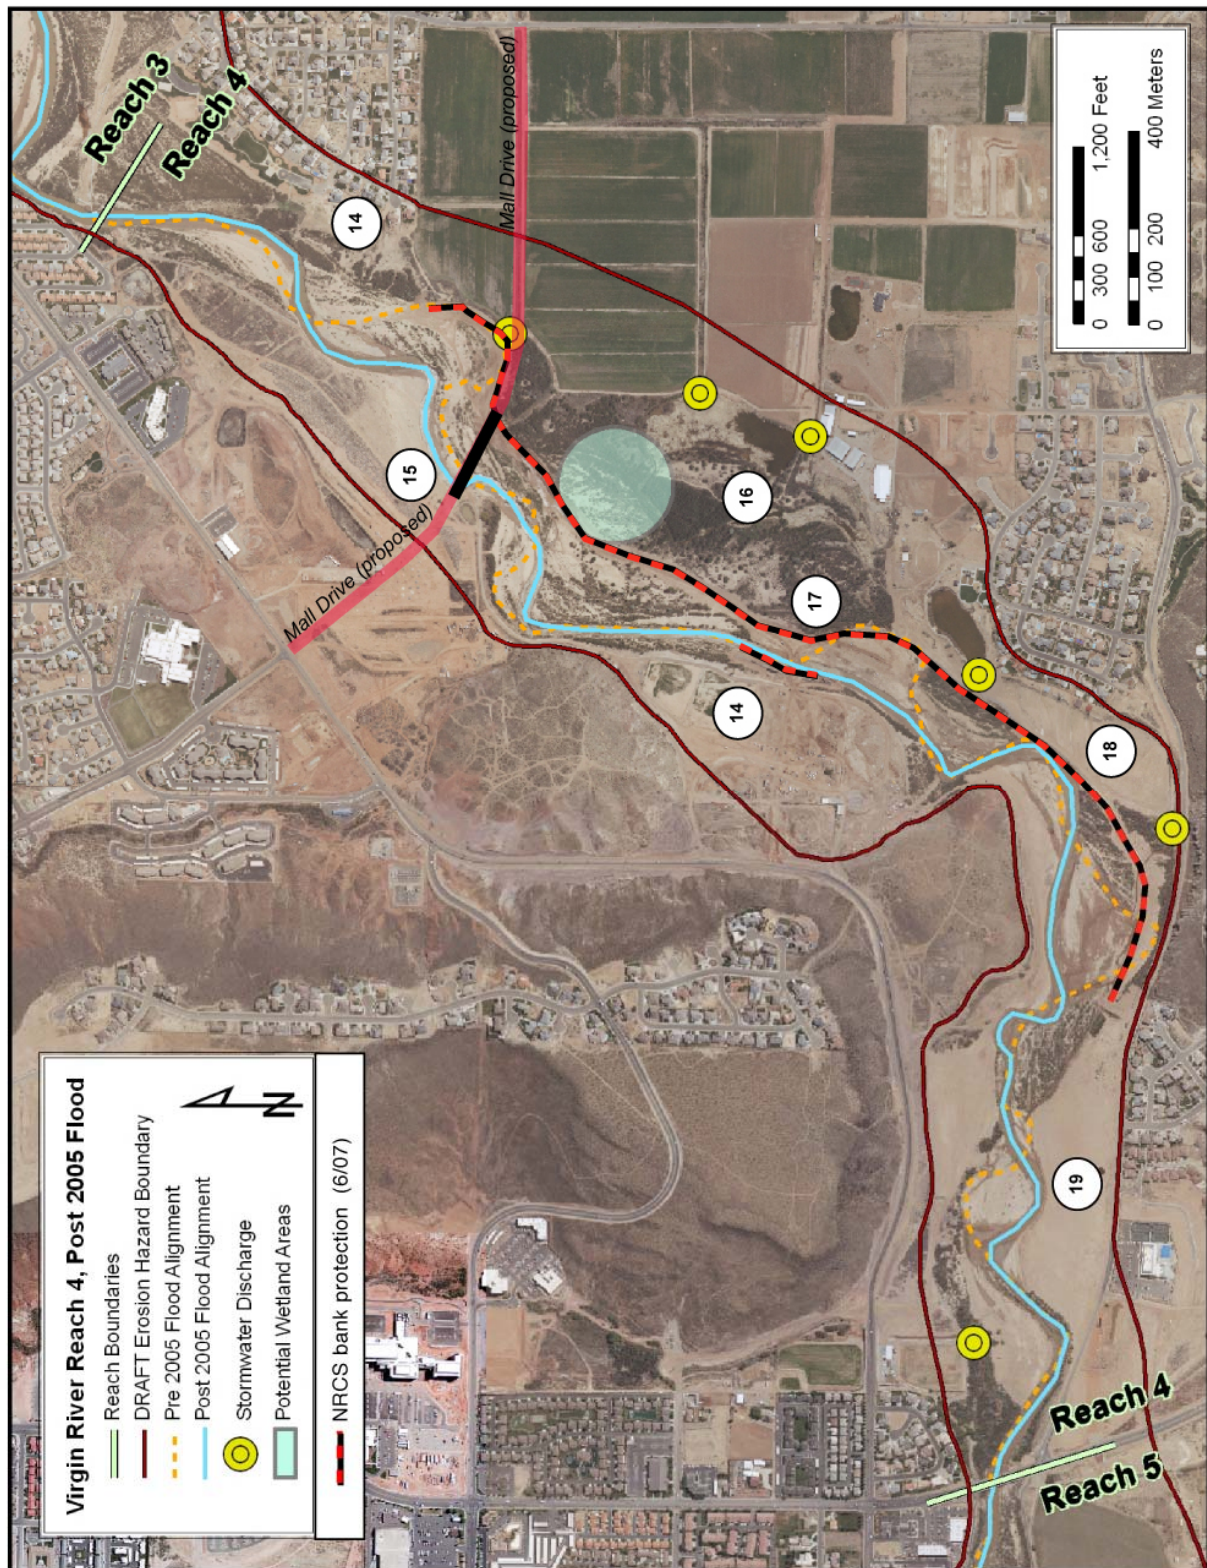
Figure 37 Reach 4 map

This reach includes the river between Johnson Diversion and River Road bridge (Figure 37). The EHZ and riparian corridor is relatively wide. Existing development is discontinuous but the large areas on both sides of the river have potential for development.

18. Corridor is narrowed by geologic control (right side) and NRCS levees (left side). Area protected by levee should remain flood terrace and be planted with appropriate native riparian plant species.

19. Open flood terraces should not be developed with hard infrastructure but could be used for parks, golf courses, and other uses where occasional flooding is acceptable. Areas should be planted with appropriate native plant species.

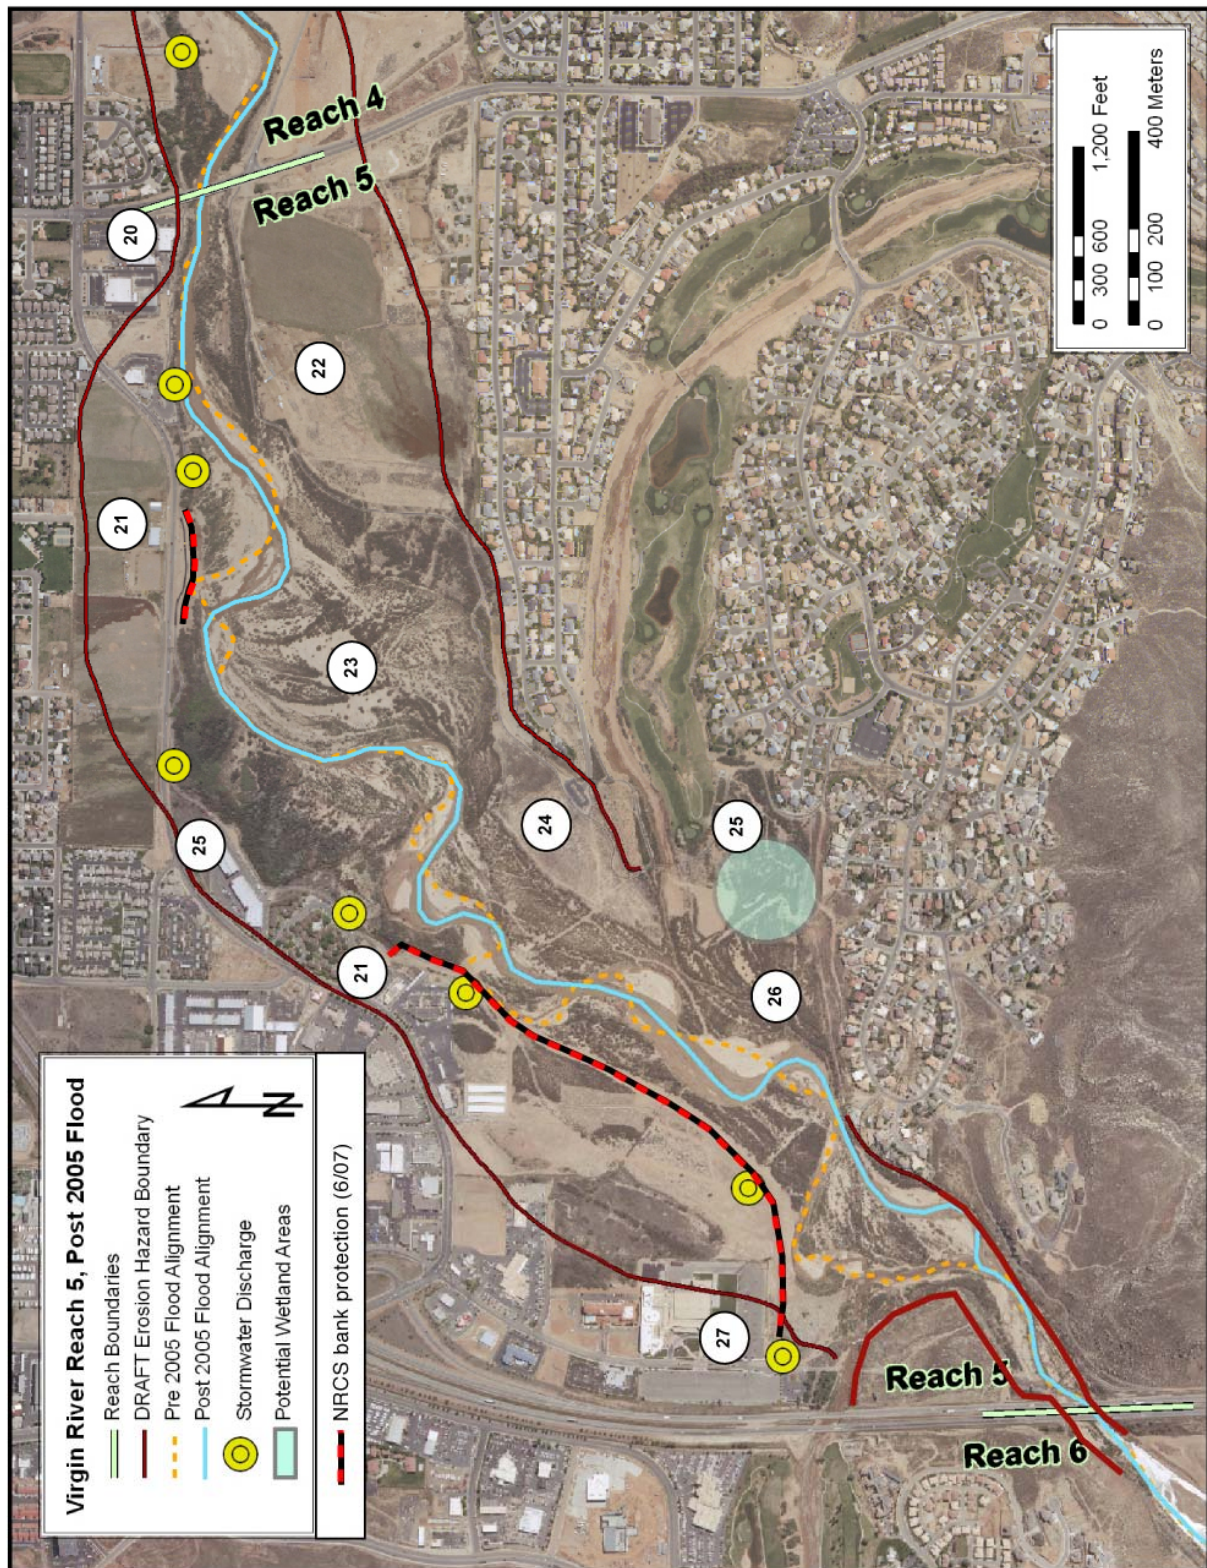
Figure 38 Reach 5 map

This reach includes the river corridor between River Road and I-15 (Figure 38). The River Road bridge creates a narrow constriction upstream but the riparian corridor and EHZ is relatively wide through most of the reach. The multitude of abandoned channel scars suggest that lateral movement is common. Substantial development has taken place within the EHZ on river left (North side) and two short NRCS levees have been installed for erosion protection. The riparian corridor narrows sharply between bedrock hills at the I-15 bridges.

25. Several areas have potential for wetland creation and stormwater treatment.
26. Ft. Pearce/Santa Clara confluences. Sediment/flood inputs make this area very dynamic with the potential for periodic local aggradation and degradation depending on hydrology and sediment contributions from the three streams. The dynamics increase the potential for unpredictable lateral meander.

27. The planned connection between Dixie Center Drive to Hilton Drive should not reduce width or restrict flow across flood terraces in this critical area.

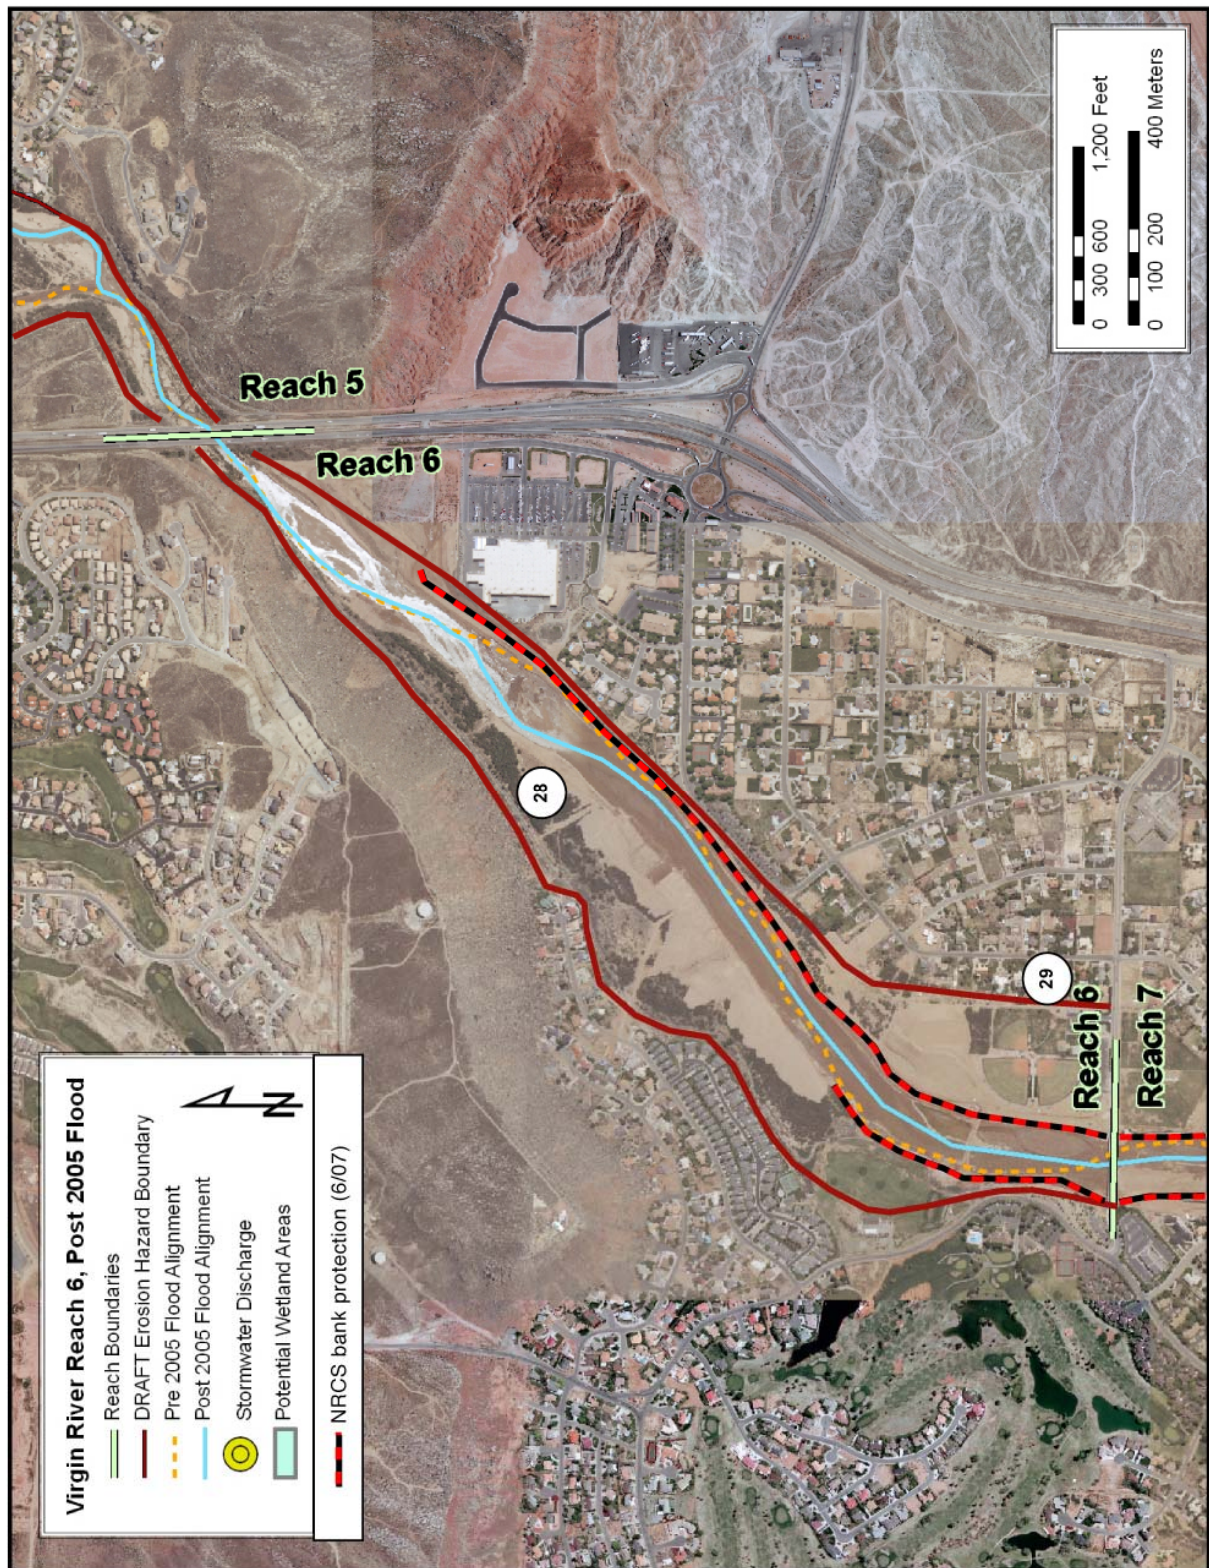
Figure 39 Reach 6 map

The reach includes the river between the I-15 bridge and Man of War bridge in Bloomington (Figure 39). The riparian corridor is narrowed by bedrock control and gradually widens downstream. Stream channel is relatively straight following the 2005 flood but can be expected to create meanders over time. The channel/floodplain areas were over-excavated following the 2005 flood and alluvial bars and other features are reforming. Areas to river right (East side) at Man of War bridge experienced flooding during 2005 when overbank flows were redirected away from the river and into neighborhoods.

28. Channel was excavated following the 2005 flood and should be planted with native vegetation to increase stability and discourage reestablishment by dense thickets of salt cedar.
29. Flooding of ball fields leads to drainage away from the river and across Man of War Drive. Topography and/or vegetation should be modified to encourage overbank flows return to the river.

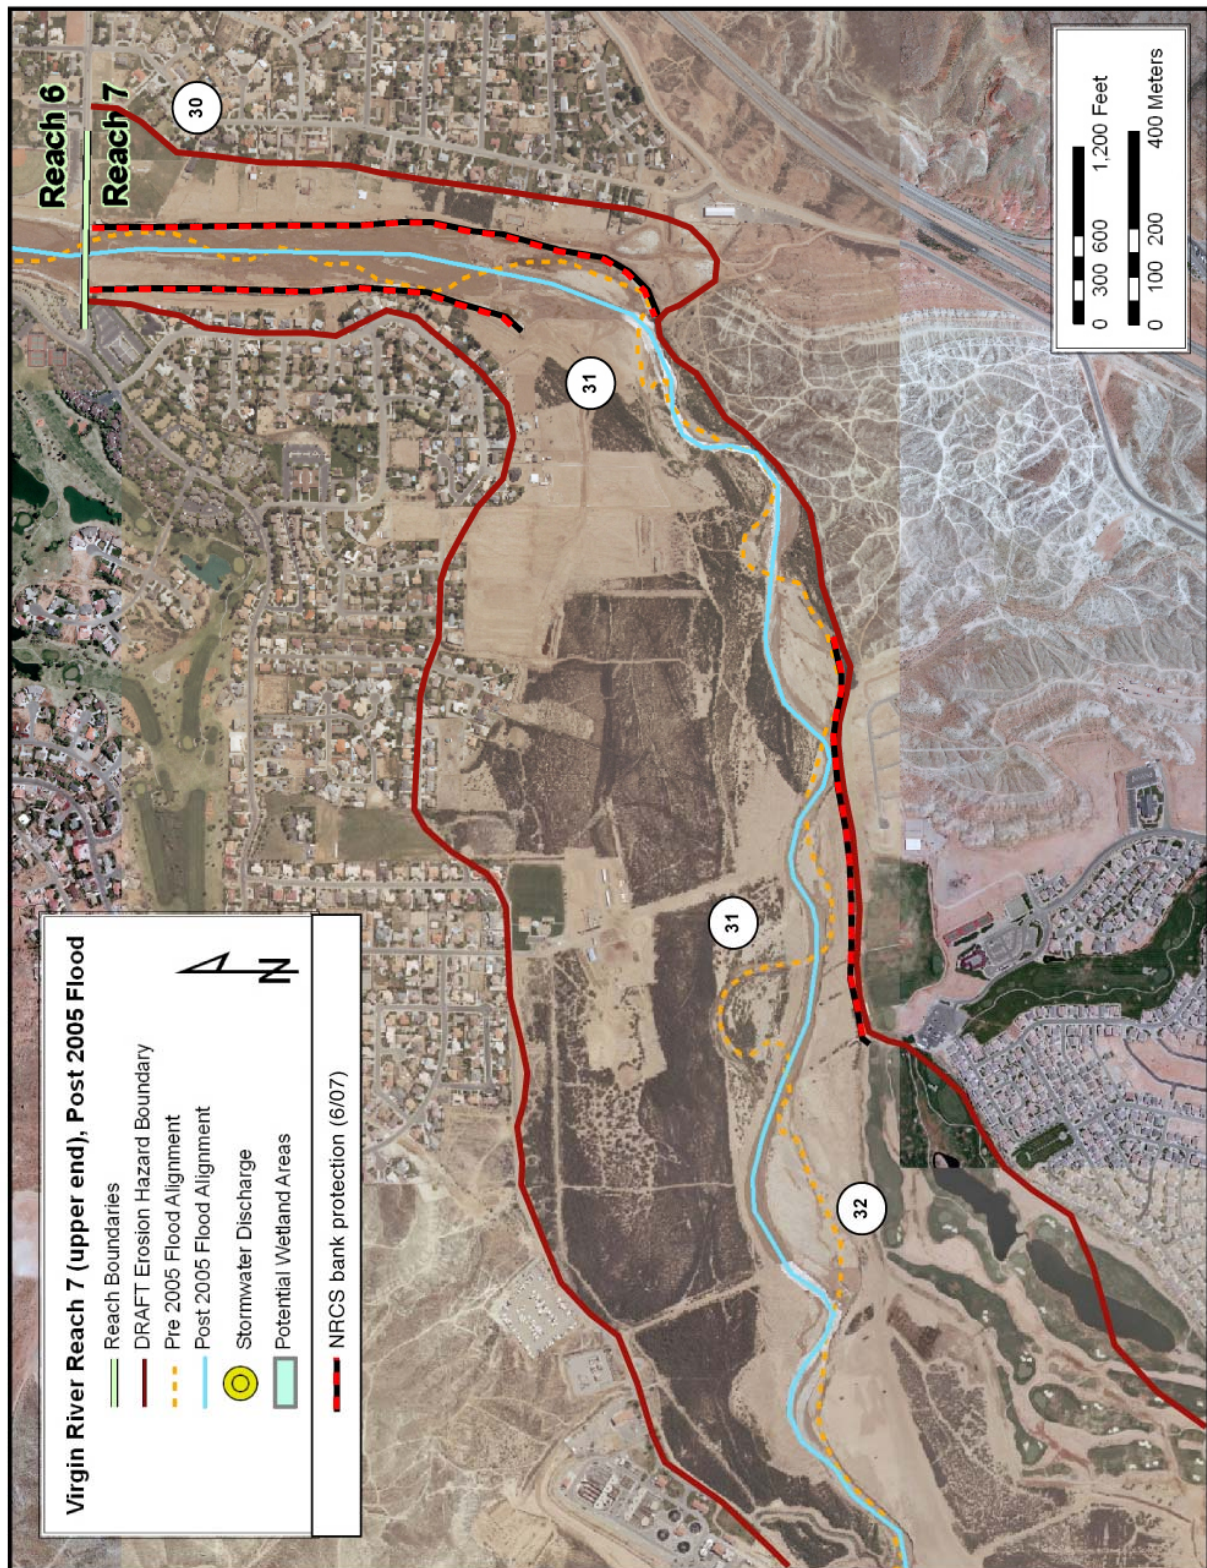
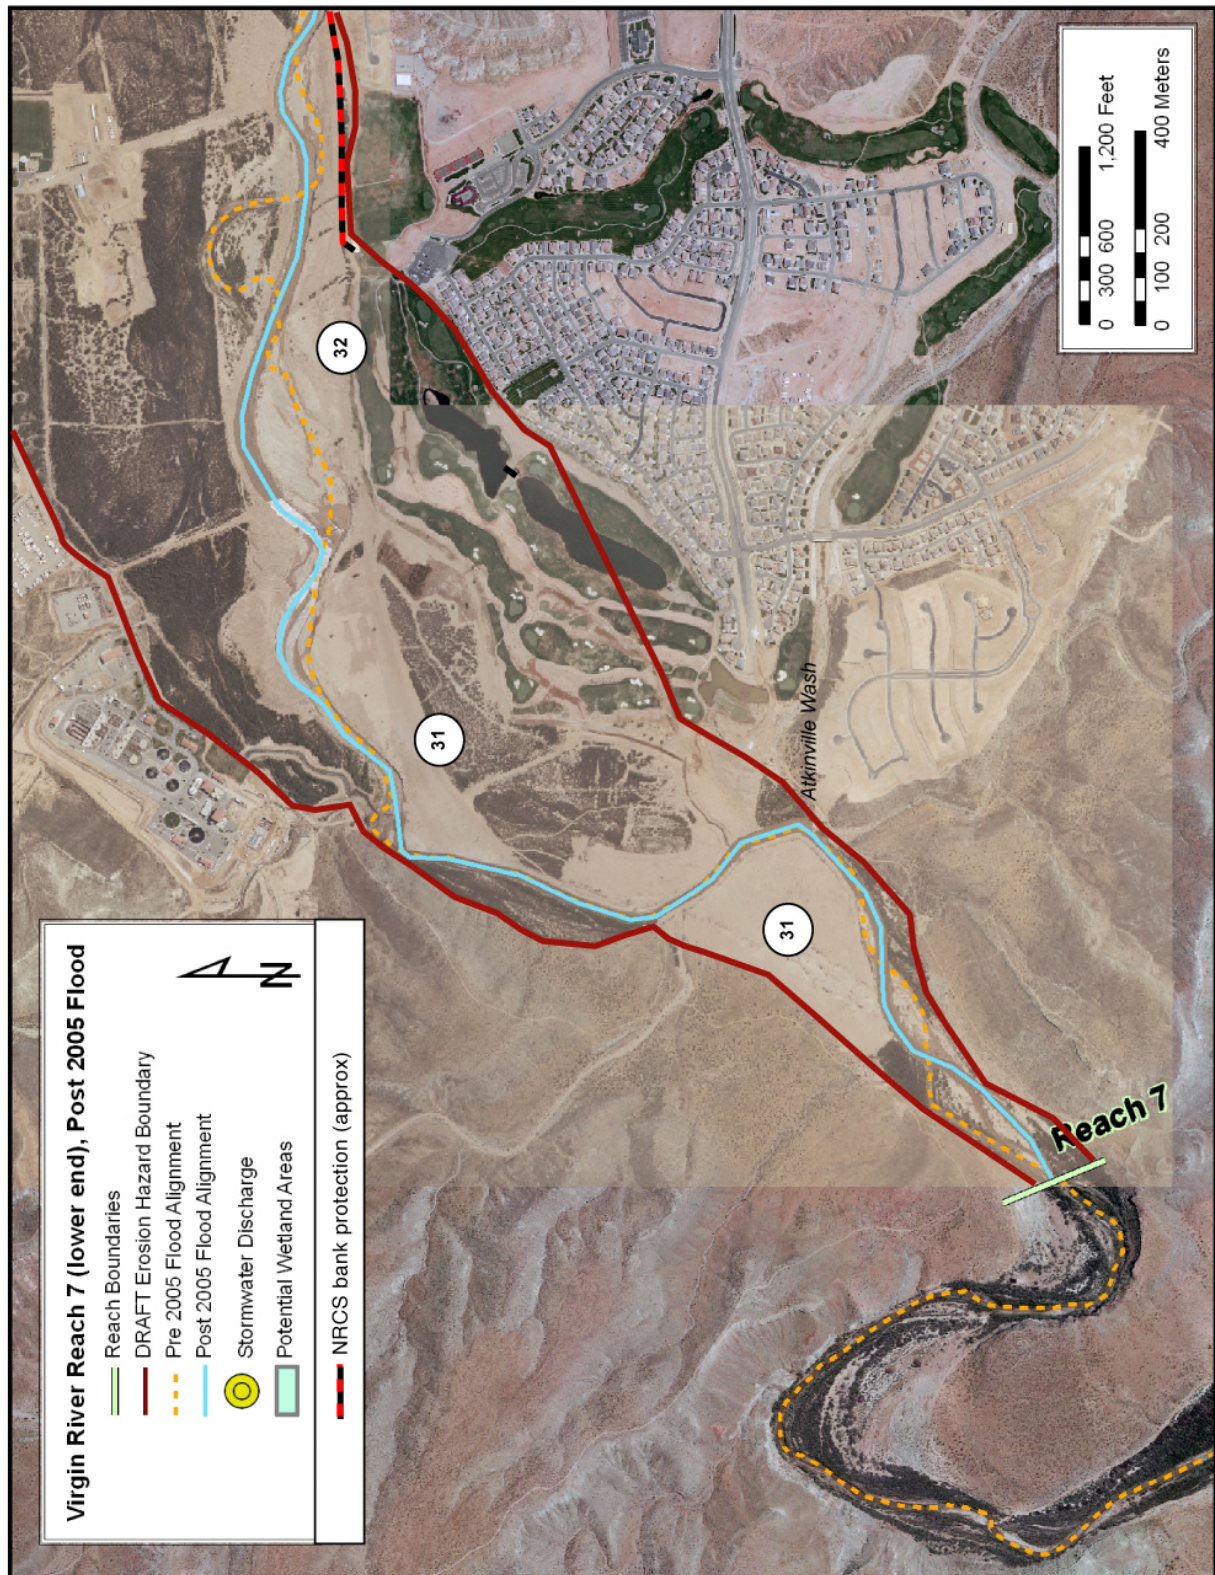
The reach includes the river between Man of War bridge and St. George city boundaries downstream of Atkinville Wash (Figures 40 & 41). The riparian corridor and EHZ are relatively narrow near Man of War bridge but widen considerably in mid-reach before narrowing as the river enters the bedrock canyon downstream. Scour scars suggest large active historic channel meandering through the wider sections of the reach. NRCS levees were installed along both sides of the river in the developed areas in Bloomington and should reduce the risk of property loss due to lateral migration. However, the levees will not necessarily reduce flood risk. Areas to river right (East side) at Man of War bridge experienced flooding during 2005 when overbank flows were redirected away from the river and into neighborhoods. The golf course at Sun River occupies much of the corridor and EHZ in the lower part of the reach and was flooded during 2005.

30. Flooding of ball fields leads to drainage away from the river and across Man of War Drive. Topography and/or vegetation should be modified to encourage overbank flows return to the river.
31. Areas throughout the corridor should be planted with native vegetation to increase stability and discourage reestablishment by salt cedar especially areas adjacent to the active stream channel. Point bars and floodplains should be dedicated to spreading flood flows. Salt cedar thickets should be replaced with appropriate native vegetation whenever possible.
32. Flooding of Sun Valley golf course during 2005 flood resulted in deposition of large volumes of sand. Upstream edge of golf course should be raised to reduce the risk of flooding and/or the course recontoured so that overbank flows are routed through the course to minimize sediment deposition.

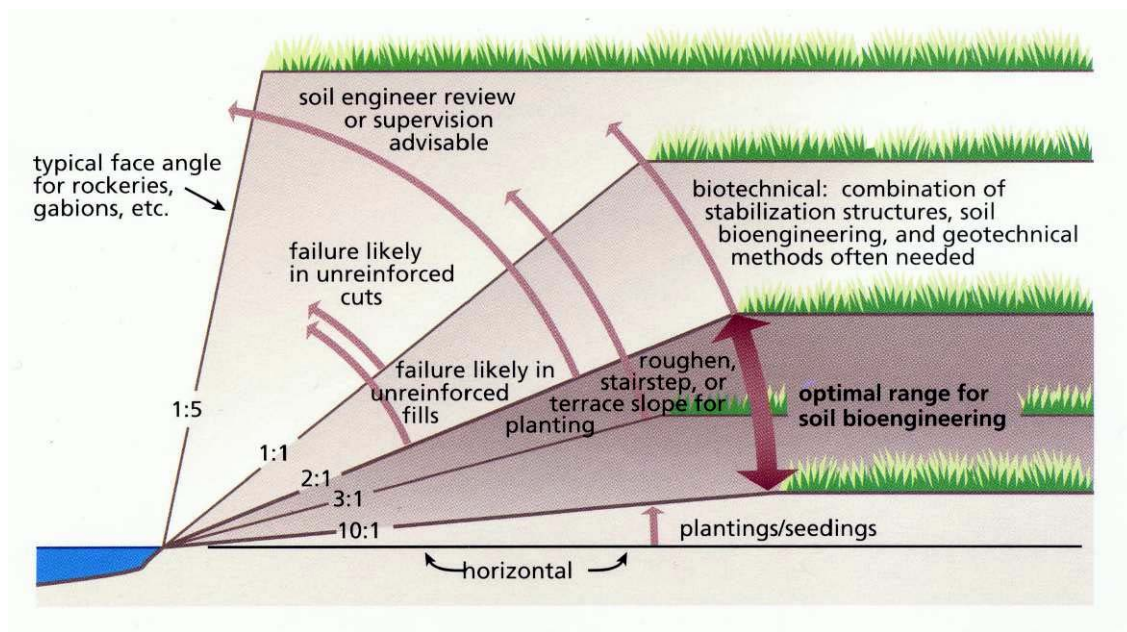
Figure 43 Stream bank slope stability

Mechanical and/or manual bank sloping greatly reduces the erodibility of stream banks. Structural stabilization such as rock generally require slopes of 1.5: or less. Bioengineering is much more successful if slopes are less than 3:1. Not only are banks more stable but vegetation grows more vigorously on gradual slopes (Figure 43).
