Landowners Handbook

**A road map for reconstruction,
management, and long-term maintenance**

Virgin River

Washington County, Utah

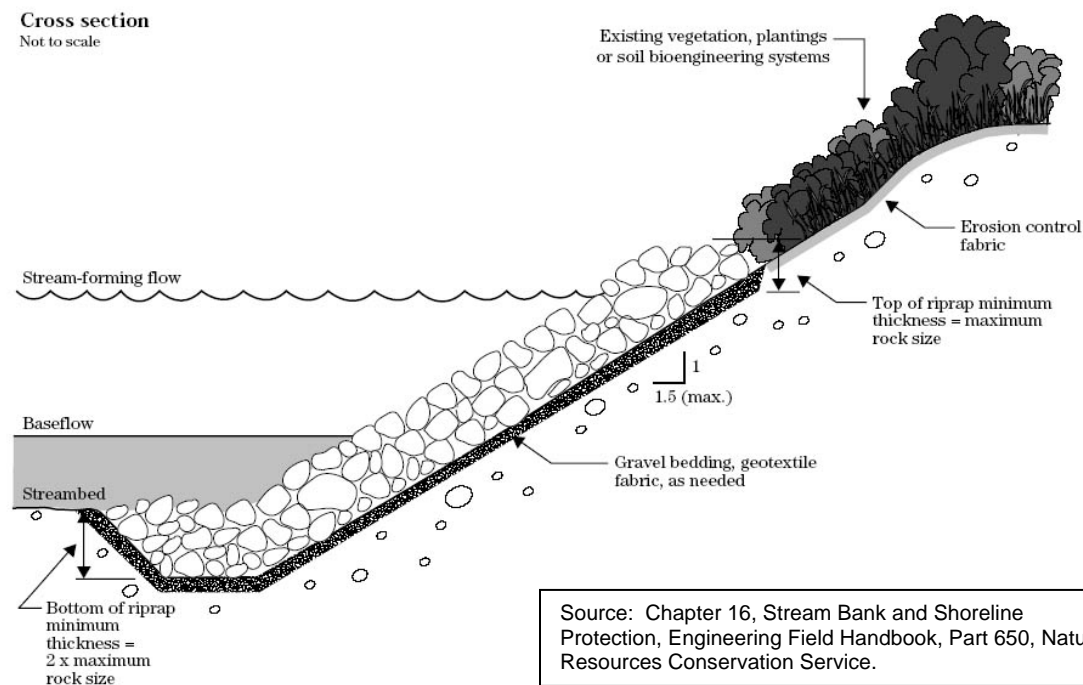
Figure 44 Toe Rock.

Toe rock is a structural practice using properly sized and graded angular rock to stabilize the toe of the bank (Figure 44). These practices are generally only necessary on the outside of a meander. Rock is installed to the floodplain elevation to allow flows to spread across the active floodplain. Rock sizing/grading, scour depth, and tie back requirements should be determined for the specific site using appropriate NRCS or other engineering procedures. Bioengineering practices should be installed along the bank above the toe rock.

This structural practice is generally installed along the outside of a meander bend to reduce the risk of lateral erosion.

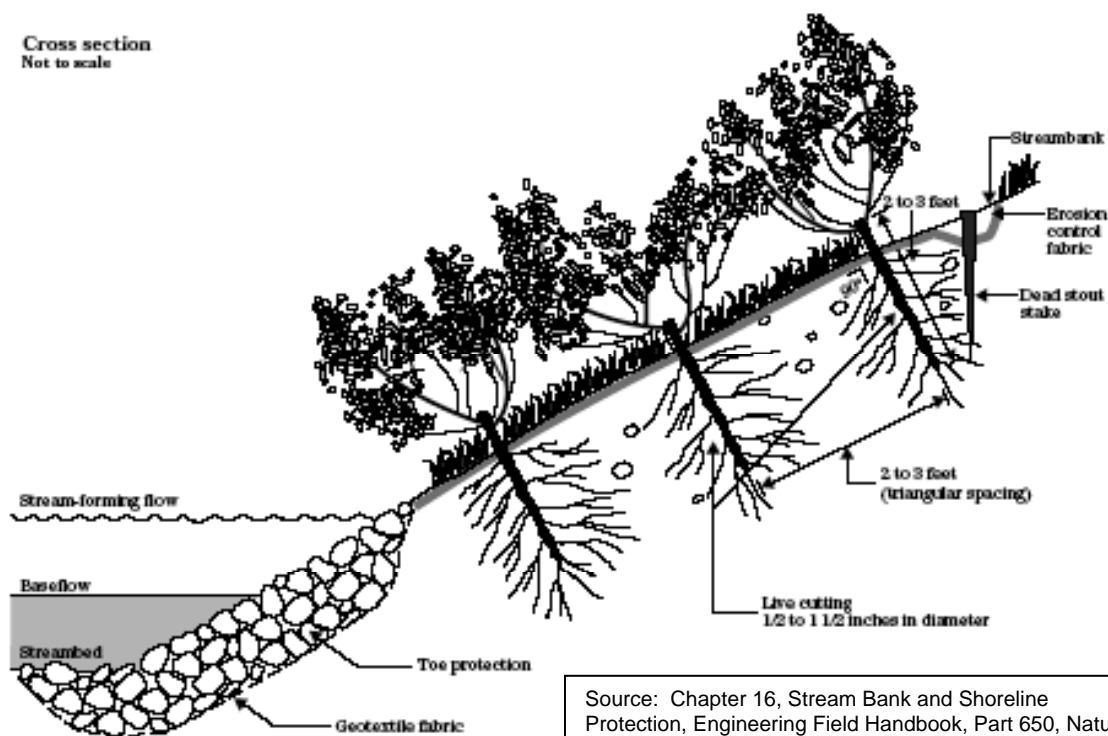
Figure 45 Live Stakes.

A system of stakes creates a living root mat that stabilizes the soil by reinforcing and binding soil particles together and by reducing near-shore flow velocities. Most willow species root rapidly soon after installation (Figure 45).

Figure 16-4 Live stake details

This structural practice can be installed with or without structural stabilization.

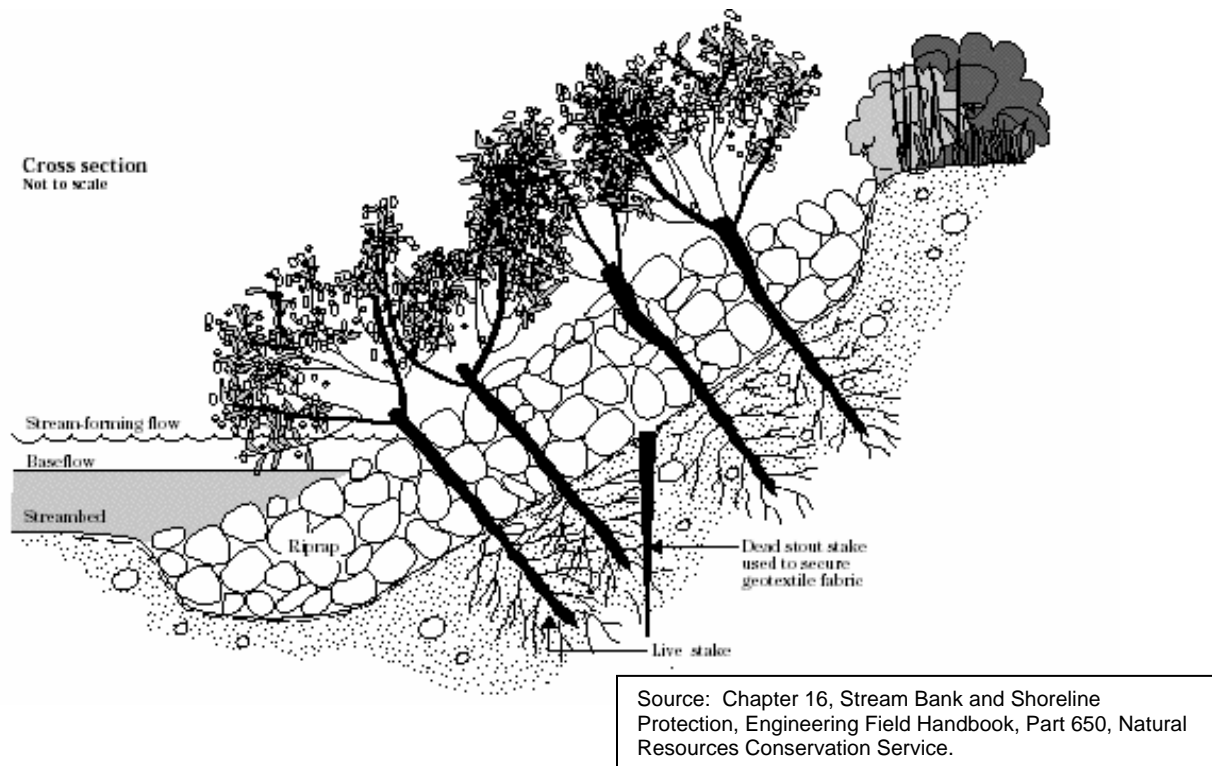
Figure 46 Joint planting.

Joint planting or vegetated riprap involves tamping live stakes into joints or open spaces in rocks that have been previously placed on a slope (Figure 46). Alternatively, the stakes can be tamped into place at the same time that rock is being placed on the slope face.

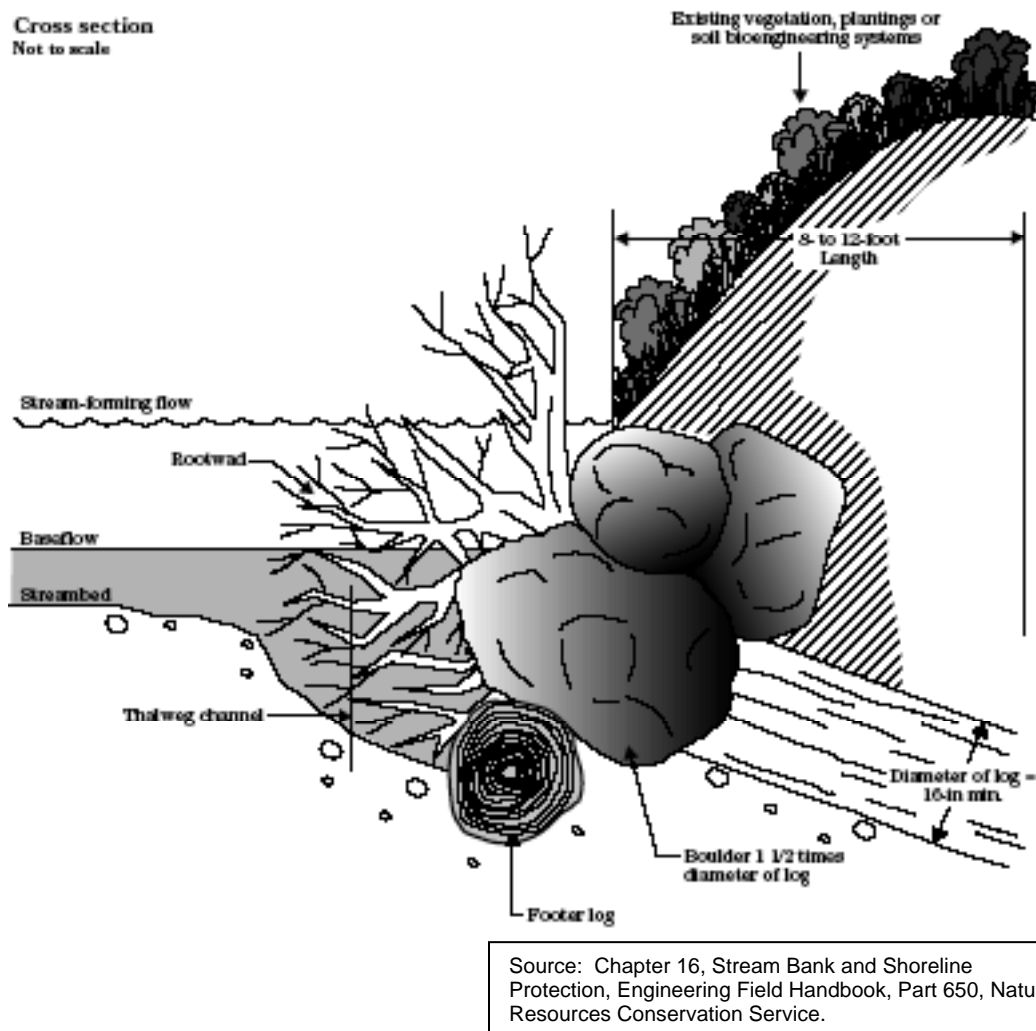
Figure 47 Root wads.

These revetments are systems composed of logs, rootwads, and boulders selectively placed in and on streambanks (Figure 47). These revetments can provide excellent overhead cover, resting areas, shelters for insects and other fish food organisms, substrate for aquatic organisms, and increased stream velocity that results in sediment flushing and deeper scour pools.

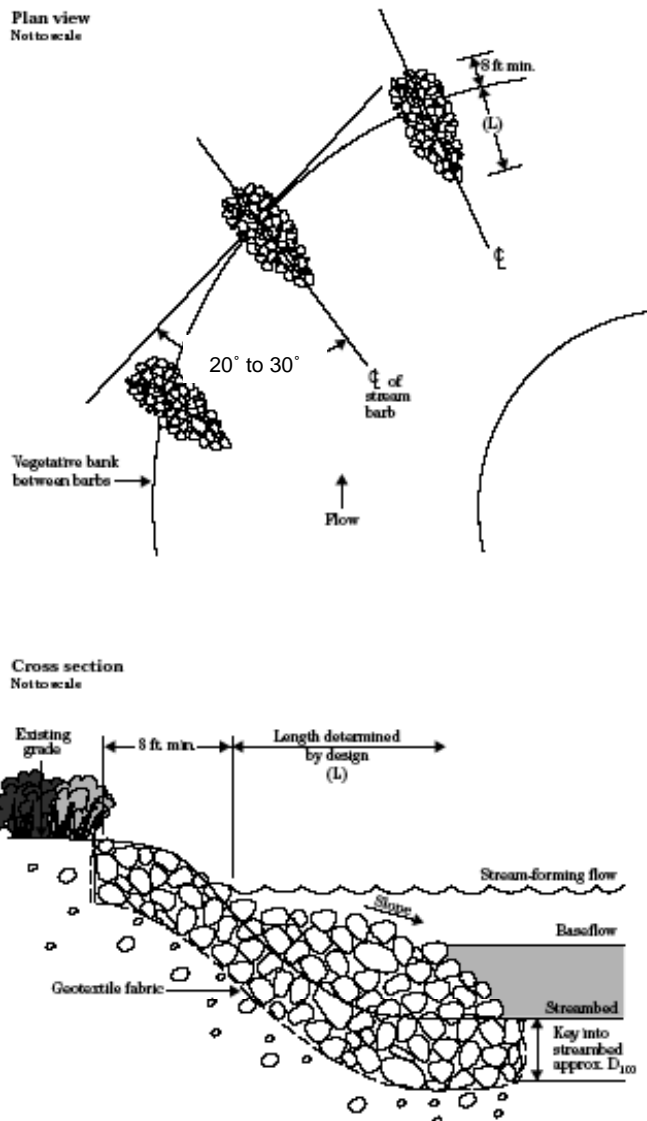
Figure 48 Stream barbs/rock vanes.

Stream barbs serve as an alternative to traditional rock armoring. Sometimes called vanes, the low structures redirect flows to the center of the channel reducing velocities against sensitive bank areas (Figure 48). The rock structures are angled sharply upstream (20° to 30°) and dip gradually (4° to 7°) downward from floodplain elevation at the bank to the channel bed. They never extend more than $1/3$ of the way across the bankfull channel (Rosgen 2002). The structures are generally installed in series along the outside of a channel meander.

These low structures redirect flows away from erodible banks and to the center of the stream channel.
